Greater Manchester's ever changing rivers

Ian Douglas

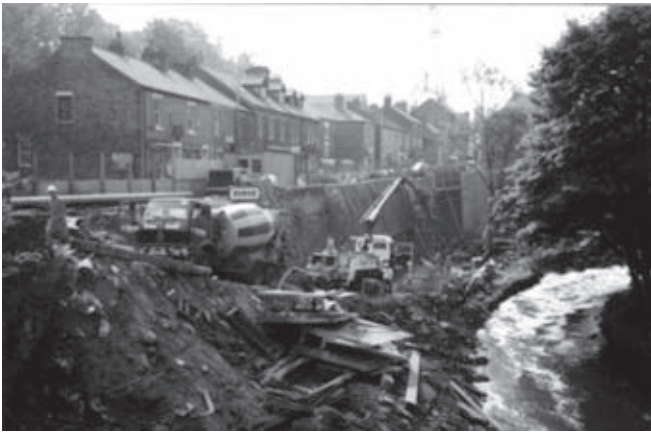
Figure 1: Repair work at Marple Bridge after the 1991 flood (source: <http://www.marplelocalhistorysociety.org.uk/stories-from-the-archive/places/164-a-tale-of-two-floods.html>)

rainfall. It reached its highest recorded level (1.96 m) at 2:45am on 22nd December 1991. The most recent peak (1.72m) was reached at 8:15pm on 5th February 2011. The 1991 flood caused part of Town Street to slide into the river, making repairs to the bridge and the channel walls necessary (Figure 1). The street was closed for many weeks for repairs, but the problem of a confined channel and a narrow bridge at the floor of a steep sided valley remained and further flooding occurred in Town Street in 2009 (Figure 2).

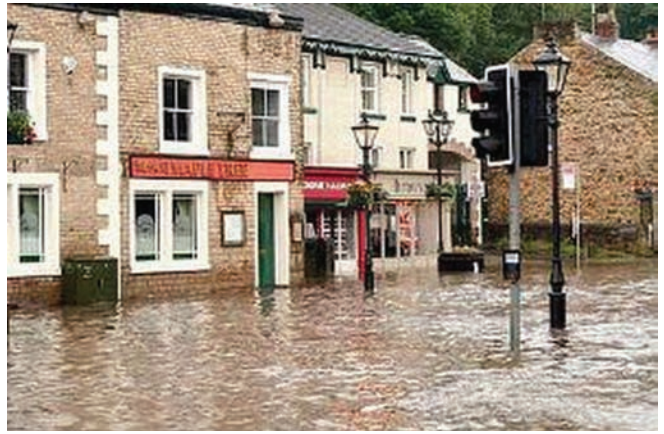
Figure 2: Flooding in Town Street Marple Bridge in 2009 (source: <http://www.manchestereveningnews.co.uk/news/local-news/flooding-anger-is-on-the-rise-926254>)

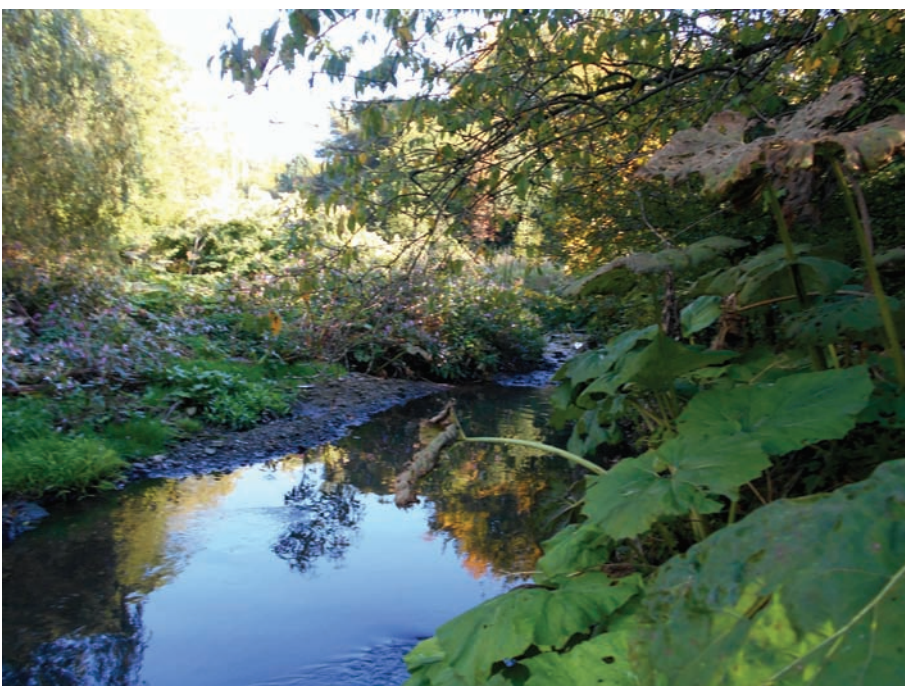
Figure 3: Looking upstream at the former meander belt above Street Bridge towards the mass of invasive vegetation now affecting the work of the river.

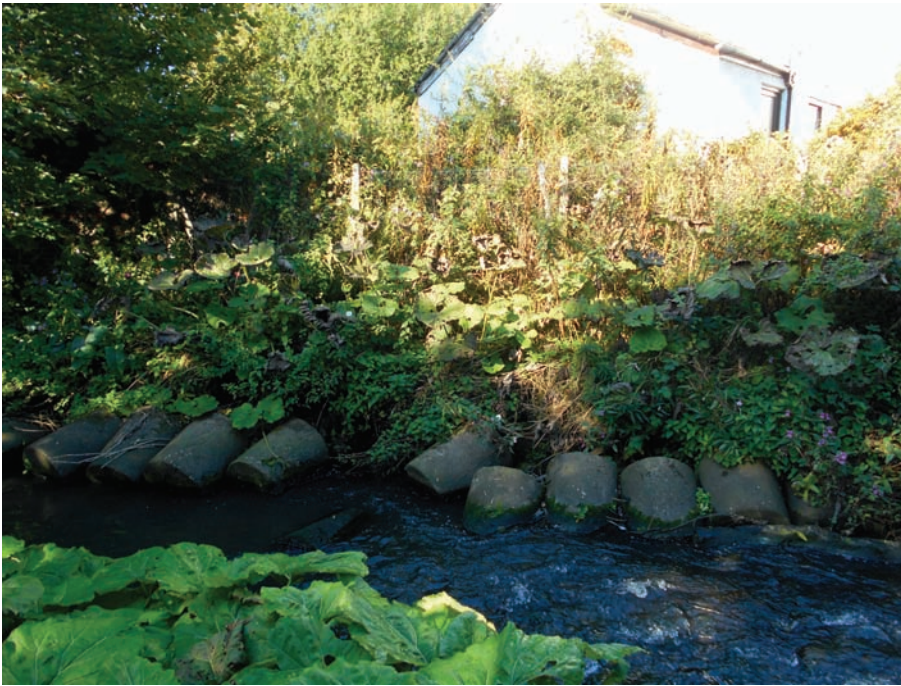
Figure 4: The Irk at Chadderton in 2015 showing concrete blocks reducing erosion on the north bank upstream of Street Bridge.

the south bank, leading to the formation of a 20 m wide meander. In early December 1964, a major storm produced about 90 mm of rain over the Irk catchment upstream of the site. This increased the flow in the river, which spilled out of its channel and formed a chute that cut off the meander loop. Pictures taken at that time show the river flowing through an open space with no trees or shrubbery. By 2015, the situation was somewhat different with young trees and abundant Himalayan balsam (*Impatiens glandulifera*), an invasive weed that is now interfering with the movement of river sediments and water on floodplains, on both sides of the river (Figure 3). This vegetation represents another type of change as an indirect consequence of human action, as opposed to the deliberate, direct action of wall building and placing of concrete blocks against the river bank (Figure 4).

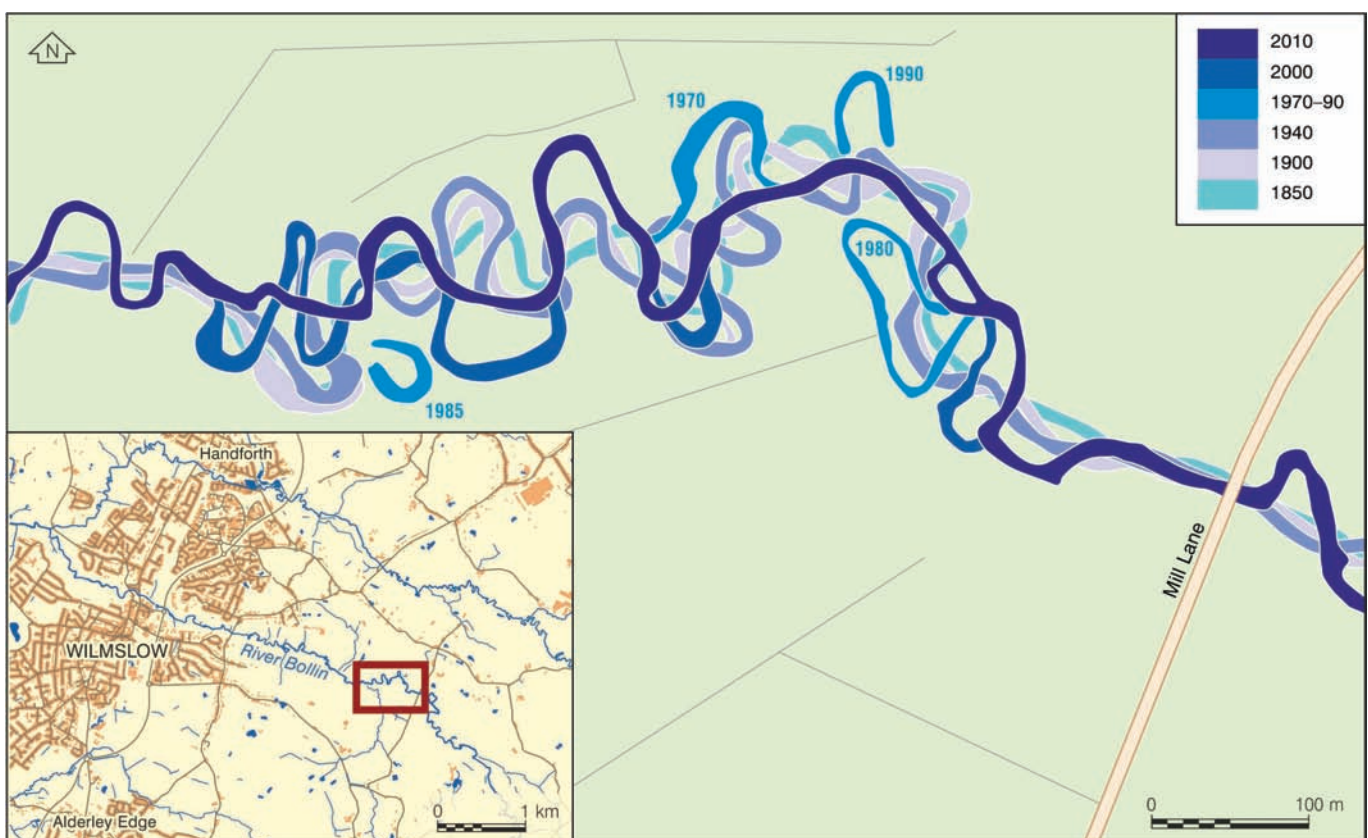
Figure 5: Meanders and cutoffs in the River Bollin north of Mottram St. Andrew (modified and augmented after Hooke, 2004).

mobile set of meanders that have been carefully mapped by Janet Hooke.³ The river in the study reach is about 8 m wide, flowing in an open floodplain through highly erodible alluvium. The banks are made up of layers of gravels and sand, comprising cobble-sized material at the base and sandy material above. Numerous old channels are present within the floodplain, but no resistant clay plugs have been found. During the winter of 2000–2001, four major cutoffs took place in a 600 m reach of channel (valley distance). One other cutoff had taken place in winter 1998–1999, and another two occurred between spring 2001 and spring 2003. The cutoffs were all neck cutoffs formed by rapid bank erosion of bends. A 2010 Google earth image of the same area reveals that further changes in the meander belt have occurred since 2003 (Figure 5). Do the rapid changes in this highly dynamic reach of the Bollin result almost entirely from natural causes or are they influenced by upstream land use changes associated with

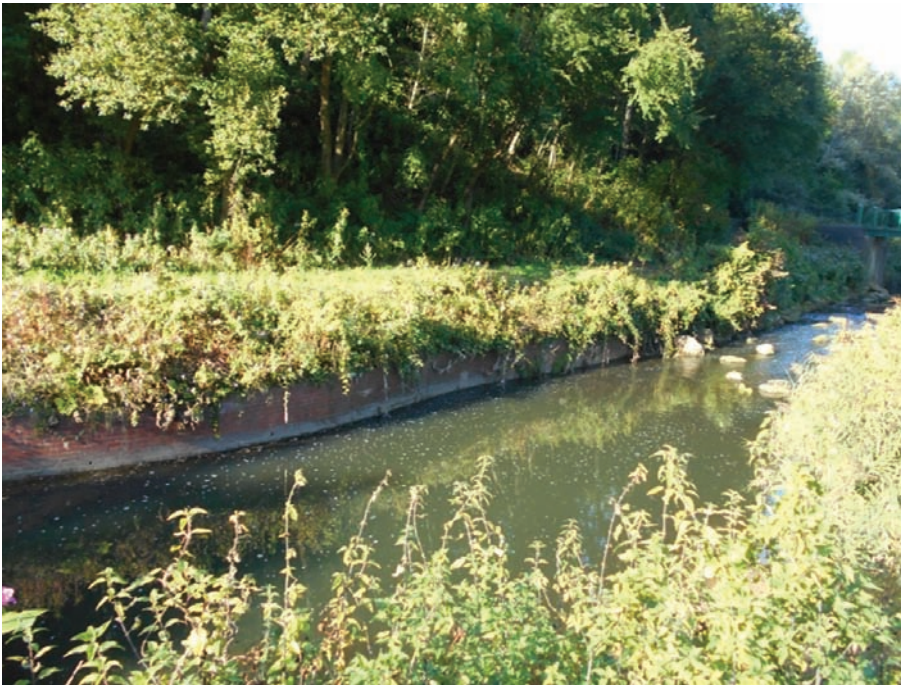
Figure 6: Brickwork installed to stabilize the channel of the Medlock at Clayton Vale.

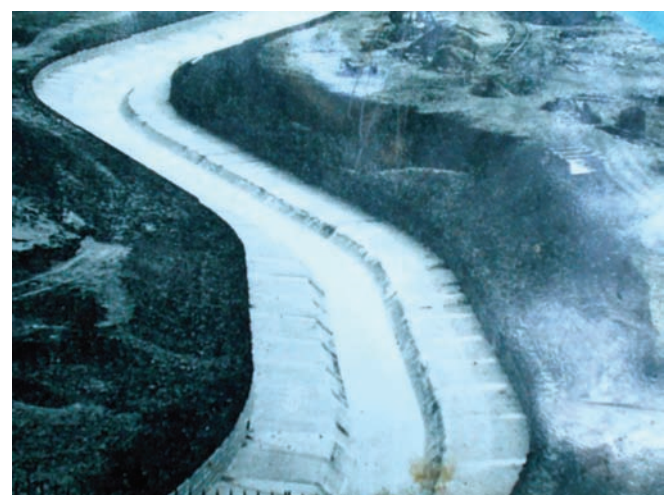
Figure 7: Photo of a picture of the double trapezoidal channel created in 1909 for the River Medlock round Philips Park and the Cemetery (from an information panel at Clayton Vale).

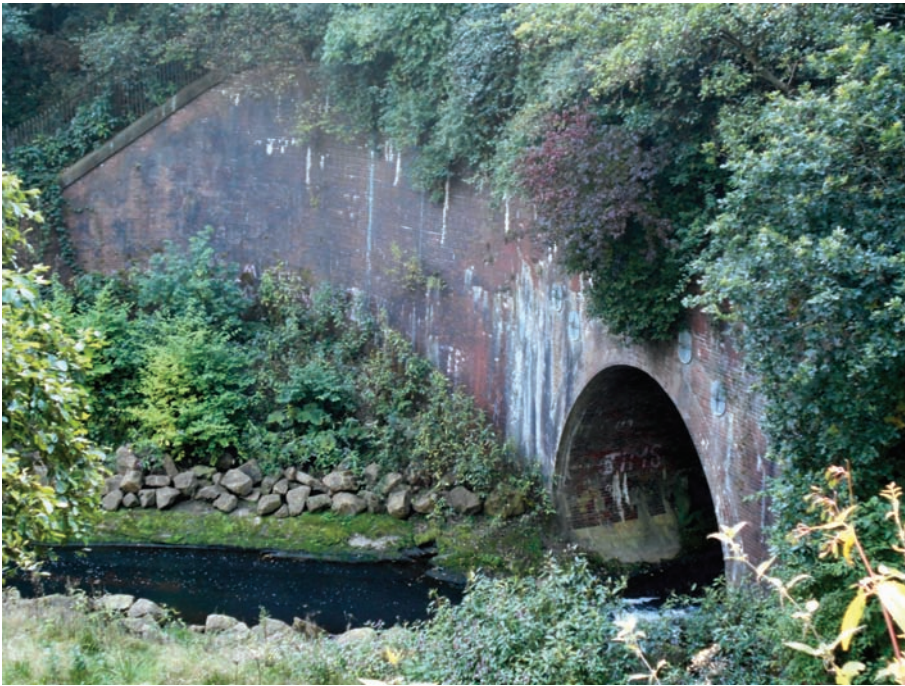
Figure 8: The regulated River Medlock entering the tunnel under Bank Bridge Road.

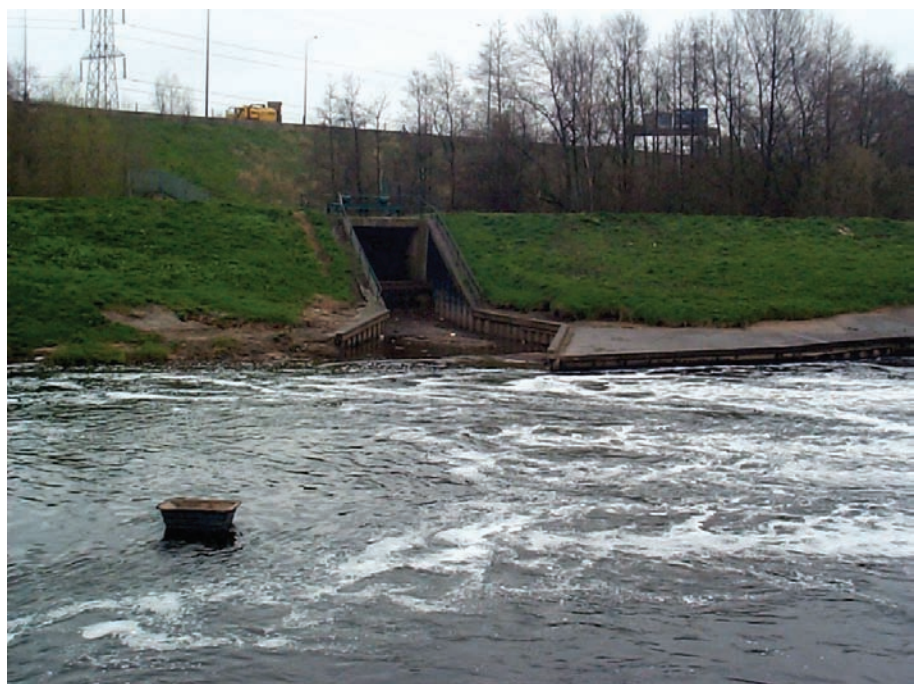
Figure 9: The Didsbury flood basin outlet weir in the Mersey embankment near the M60 at Northenden.

floodplain which act as temporary storage basins. The water can return to the river through weirs at Northenden (Figure 9) and below Sale Water Park. At Chorlton (Figure 10) and Sale, former gravel pits that were used to supply aggregates for the construction of the M60 motorway have been converted into multi-purpose permanent artificial lakes (water parks), providing such ecosystem services as leisure activities, wildlife habitats and flood storage. The reductions of peak flows by

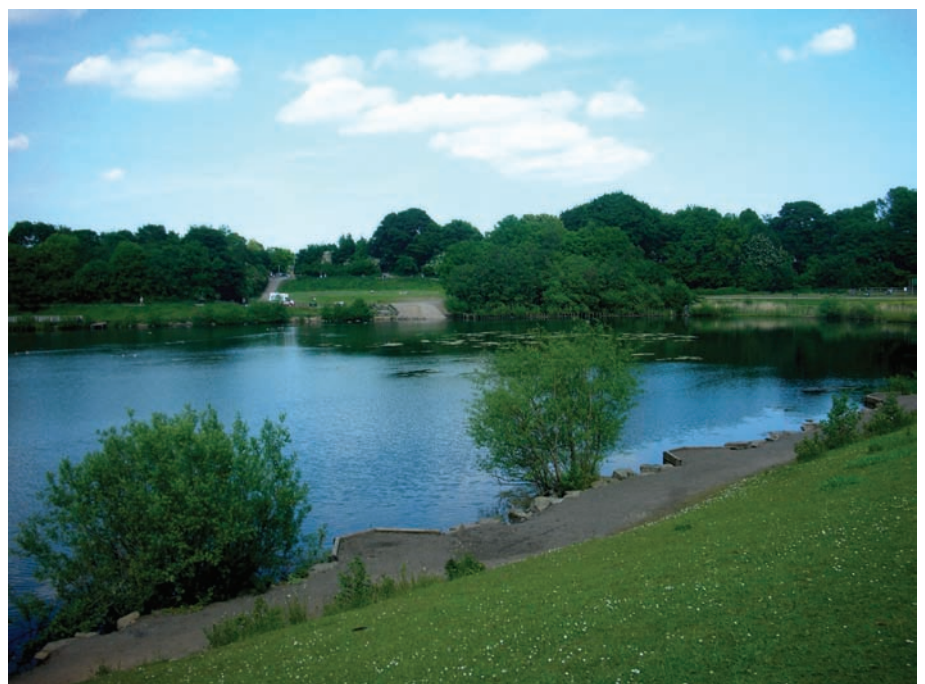
Figure 10: Chorlton Water Park.

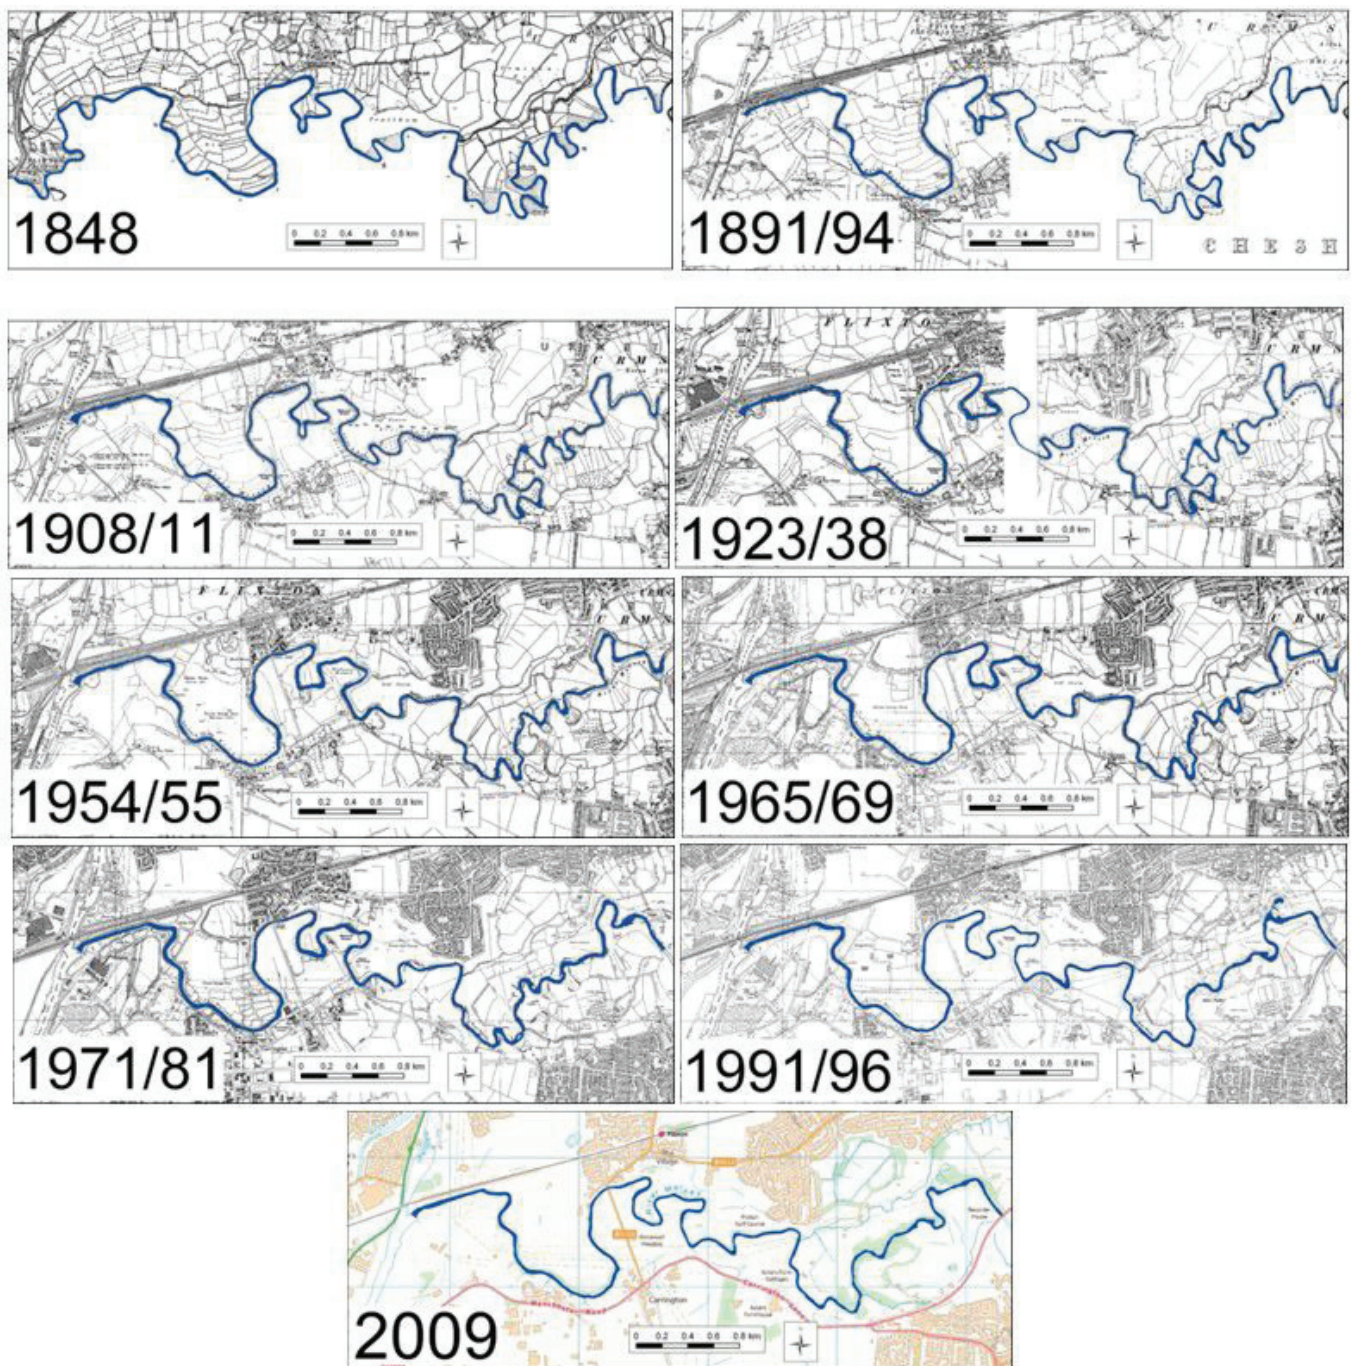
Figure 11: Changes in the meander belt of the River Mersey downstream of Ashton Weir (after da Luz et al., 2015).

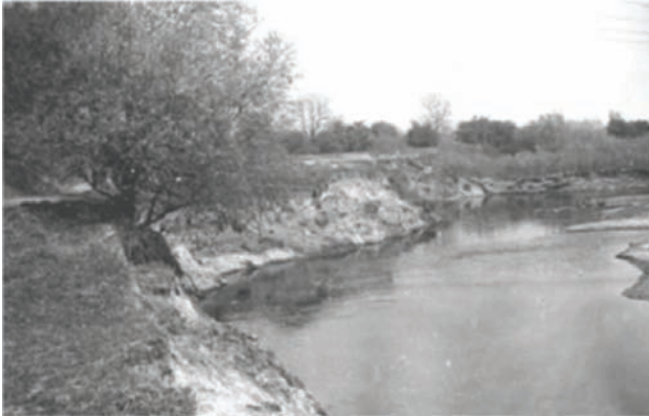
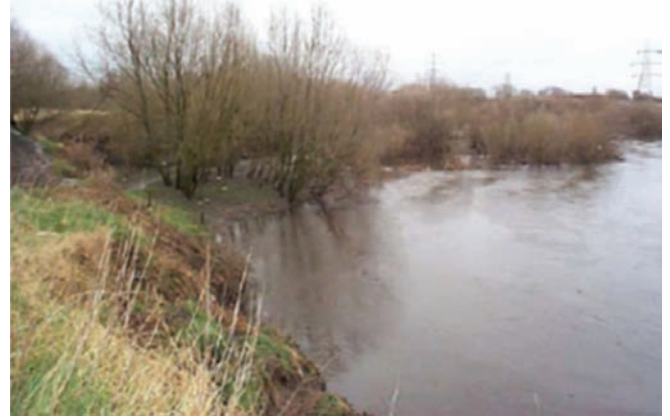
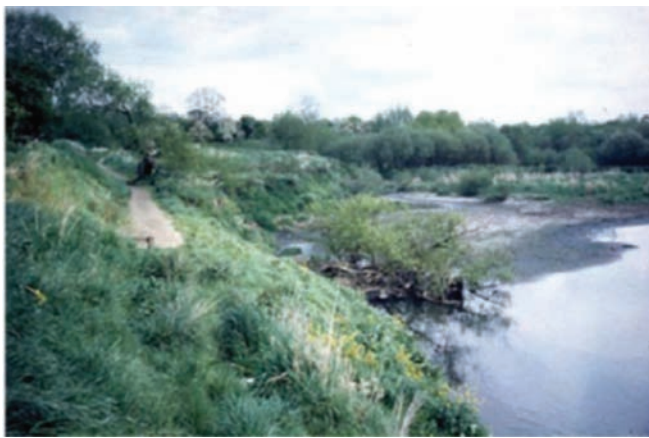
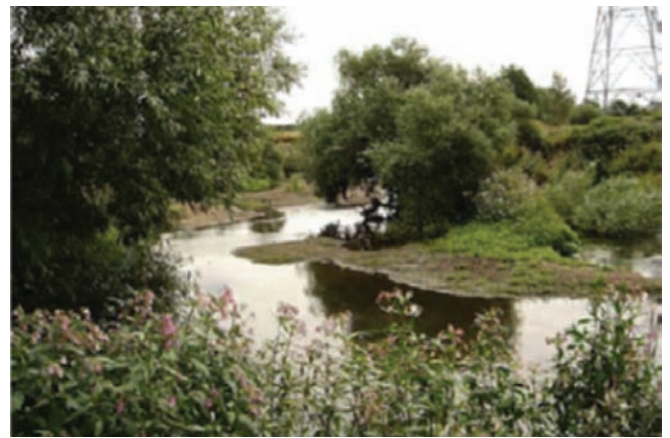
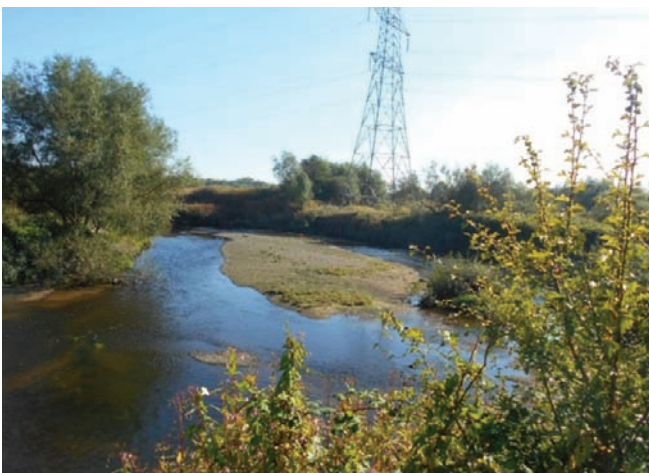
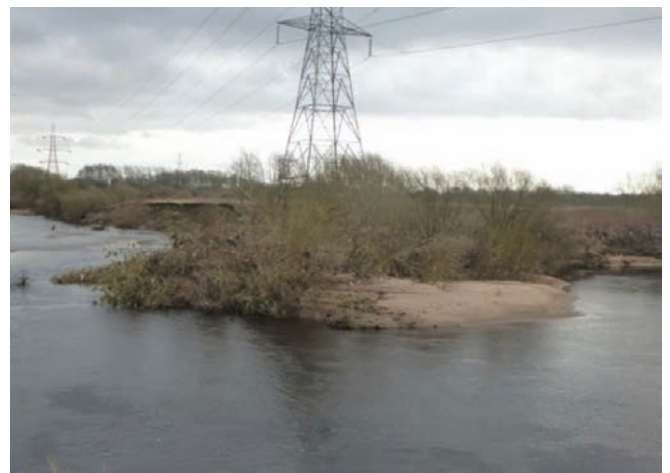
Figure 12: Changes to the River Mersey near Urmston over 30 years 1986-2016

(a) 1983: Willow tree roots exposed on eroding bank.

(b) 1986: Bank has eroded significantly, sand accumulating around new branches growing from the fallen tree

(c) 1989: Fallen tree now surrounded by water, bank erosion continuing.

(d) 2005: Channel has changed considerably; major point bar in the centre.

(e) 2015: Point bar now almost clear of vegetation; far bank eroding.

(e) 2016: Further erosion of far bank.

A sequence of photographs (Figure 12) shows how a willow tree fell into the river from the bank in late 1986, when 2 m of the bank collapsed during a flood, and how the bank (left foreground) continued to be eroded as a small gravel bar which extended downstream (towards the photographer) in the decade after 2005. By 2015, the outer edge of the meander had migrated some 200 m downstream from the meander cutoff. Flood flows on 26th December 2015 eroded the banks even more. The 25th January 2016 photograph clearly shows that the far bank is closer to the pylon than it was four months before. The banks suffered significant erosion during high flows after the heavy rains of 26th December 2015 (Figure 13).

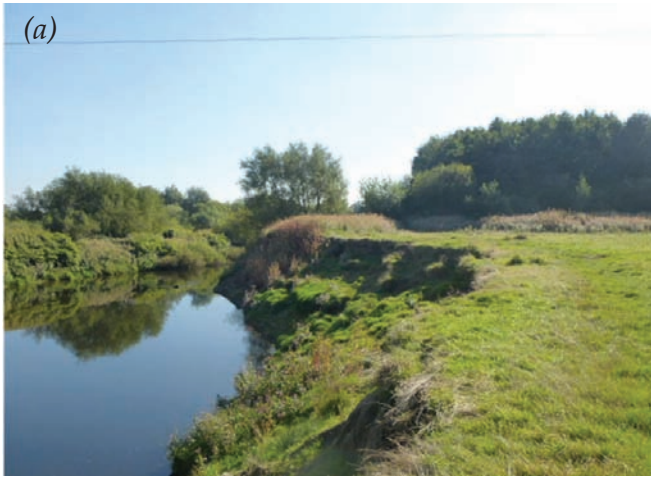
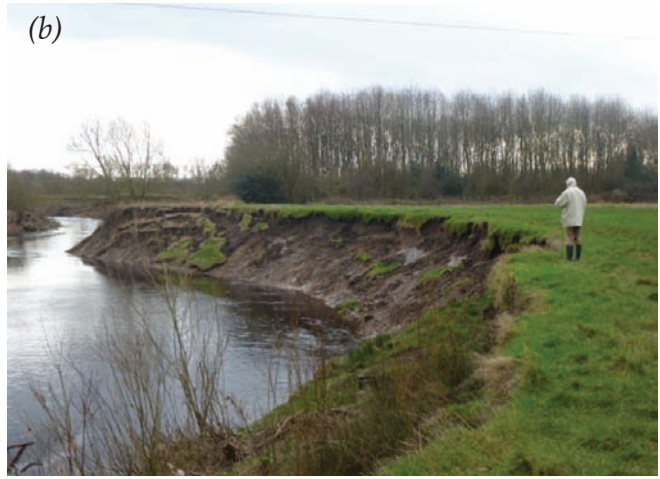
Figure 13: Pictures of the north bank of the Mersey at Urmston showing the situations in (a) September 2015 and (b) January 2016, with the changes due to the high flows in late December 2015.

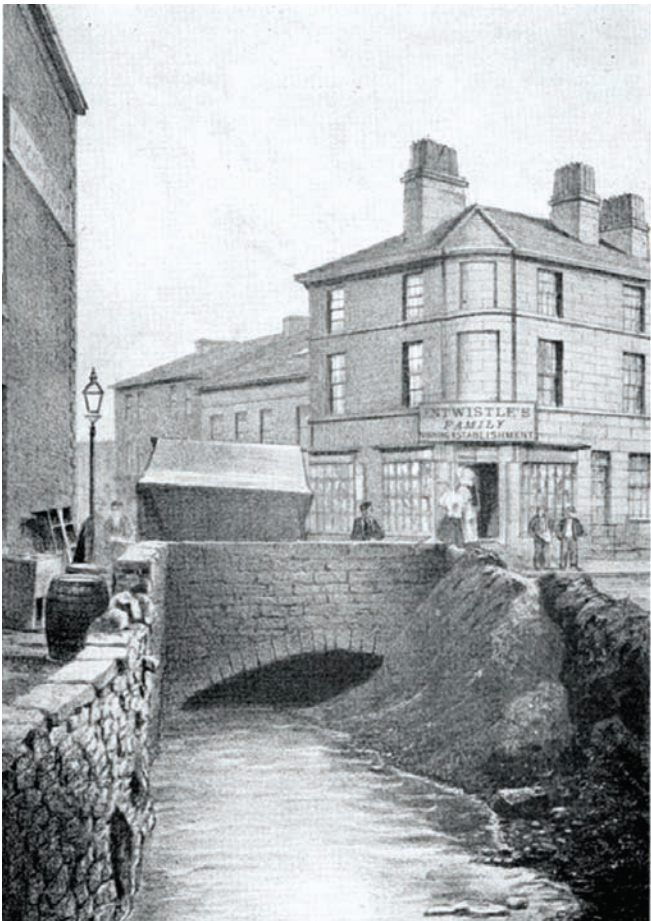
Figure 14: The 19th century River Irwell at Bury where debris thrown into the river has left little room for high flows to pass under the bridge.

In the nineteenth century, Manchester's rivers were frequently encumbered by debris thrown and dumped into their channels. As many localities lacked garbage collections, ashes from fires and other waste were simply thrown over parapets into the flowing water (Figure 14). The debris was carried downstream from the steep upper reaches and some of it was deposited as stream gradients decreased (Figure 15). So great was this deposition in the meandering Salford reaches of the Irwell that the local council took the upstream urban authorities to court, to restrain them from reducing the capacity of the river and contributing to the regular severe floods in Salford. In 1868, the increased flooding and pollution of the Irwell led to a government commission to enquire into "the best means of preventing the pollution of rivers (Mersey and Ribble basins)". The Royal Commission's report⁵ contains excellent drawings showing the changing amount of silt in the Irwell below bridges in Salford and Manchester.

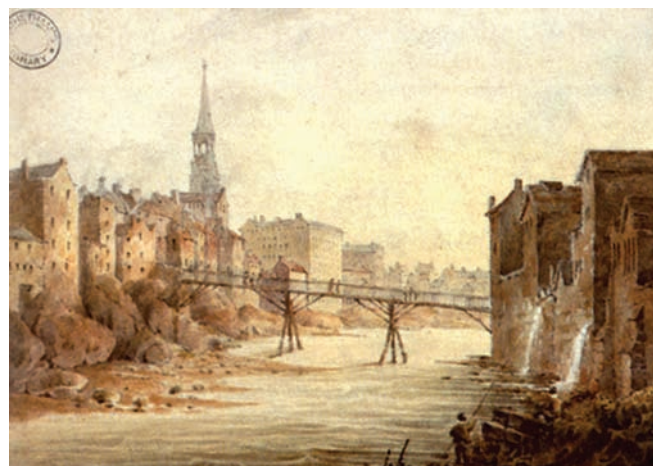
Figure 15: In the 18th century waste water is being discharged straight into the Irwell between Manchester and Salford and much debris partly blocks the channel.
