# **North West Geography**

Volume 3, Number 1, 2003

# Breakdown mechanisms and morphology for man-made rock slopes in North West England

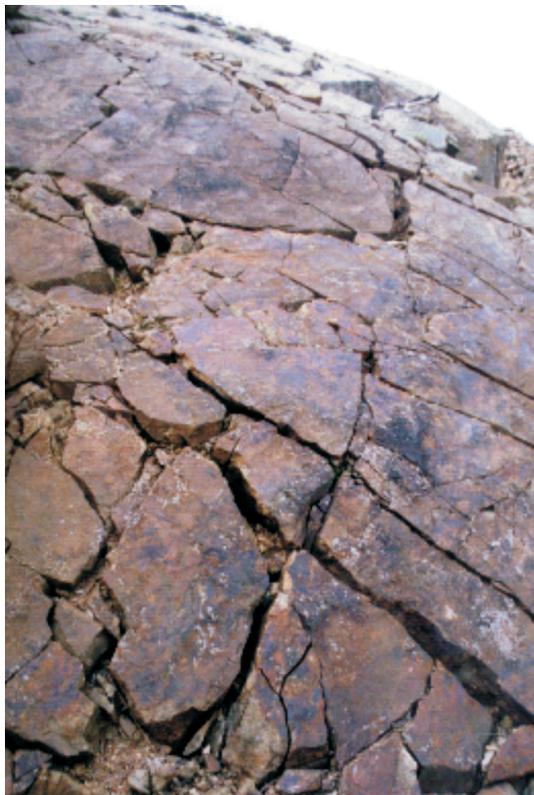
Figure 1: Wide aperture fractures resulting from blast-induced stress release: Block release could induce larger scale rockfall (Knock Pike Quarry, Lake District).

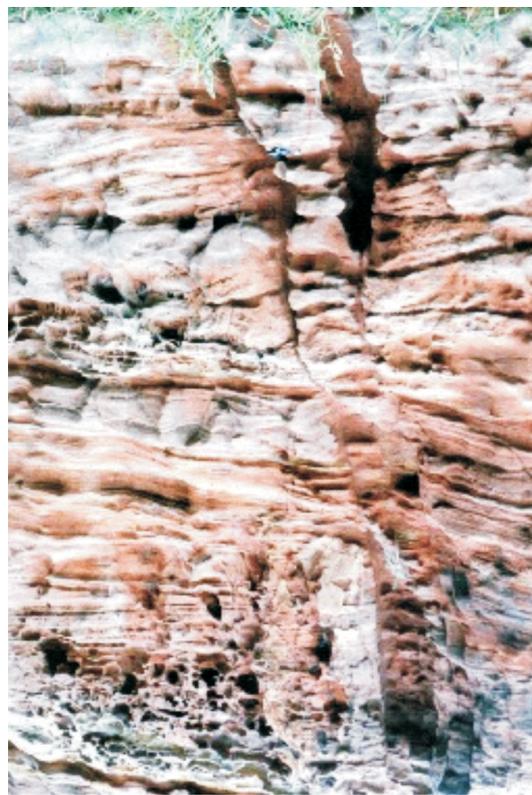
Figure 2: Honeycomb weathering leading to risk of cavity collapse (Runcorn Expressway, A557).

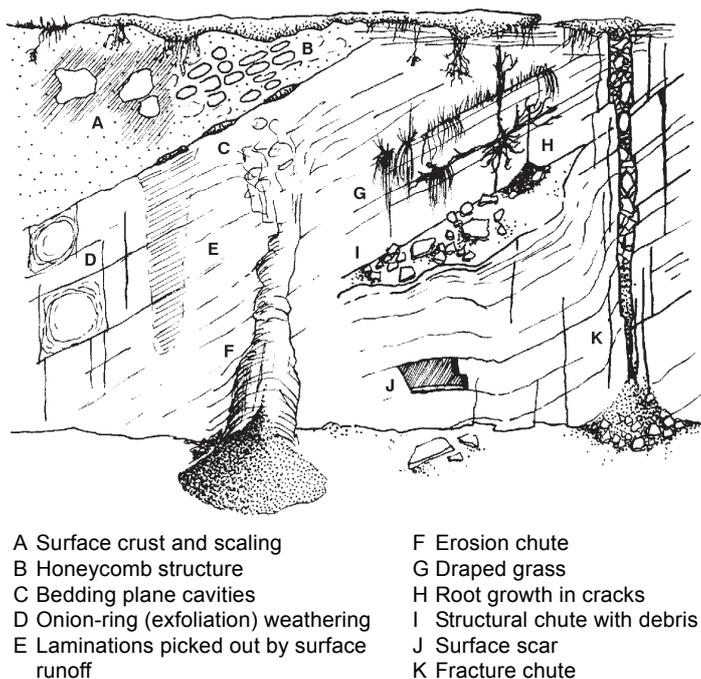
Figure 3: Erosional morphology due to deterioration.

<b>Erosional landforms</b>
Erosion only takes place when material which has become detached from the rock mass is removed by transport agents, to be subsequently deposited elsewhere. Much material may remain <i>in situ</i> (see below).
<i>Chutes</i> are quasi-channels down which loose material is transported. They are characterised by having debris piles at the foot, in some cases with a wide spread of debris in or on chute surfaces. Three sub-types of chute were identified. Erosional chutes occur where rock material has been cut into by erosive agents, usually surface water runoff. They can also form from dissolution. Fracture chutes occur where fracture aperture has been enlarged (e.g. due to wall breakdown). Structural chutes are strictly not an erosional landform. They are the product of the intersection of discontinuity planes with the slope plane. Nevertheless, they provide conduits for downslope movement of material and commonly contain accumulated debris, soil and vegetation. They therefore function as chutes and are susceptible to surface erosion.

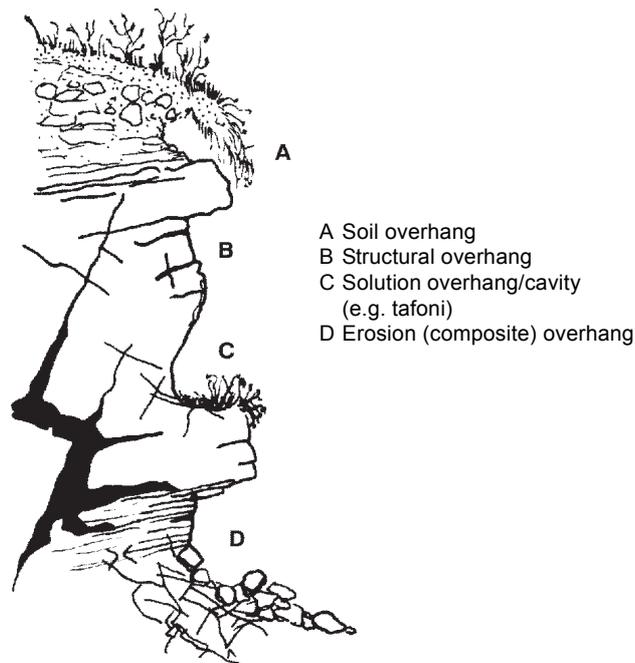
Figure 4: Deterioration-related slope overhangs.

<i>Overhangs</i> occur in a range of situations and three sub-types can be recognised. Structural overhangs have a similar origin to structural chutes. Erosional or composite overhangs occur where competent materials are undermined by erosion of underlying weaker strata or by basal undercutting in homogeneous materials (Figure 7). Solution overhangs may be produced in soluble rocks. Runnels may be regarded as incipient solution chutes.
<i>Cavities</i> are an erosional form which may be transitional with overhangs (e.g. tafoni). There are several types of deterioration-related cavity. Honeycomb weathering often produces small cavities in the form of alveolar structure. Localised and small scale cavities often form along horizontal discontinuities such as bedding planes, probably representing the early stages of undermining. Larger scale Man-made cavities such as mine adits may rarely be exposed in excavations. Cavities of a wide range of shapes and sizes can be formed from solution. Palaeo-solution cavities may also be exposed in excavations.

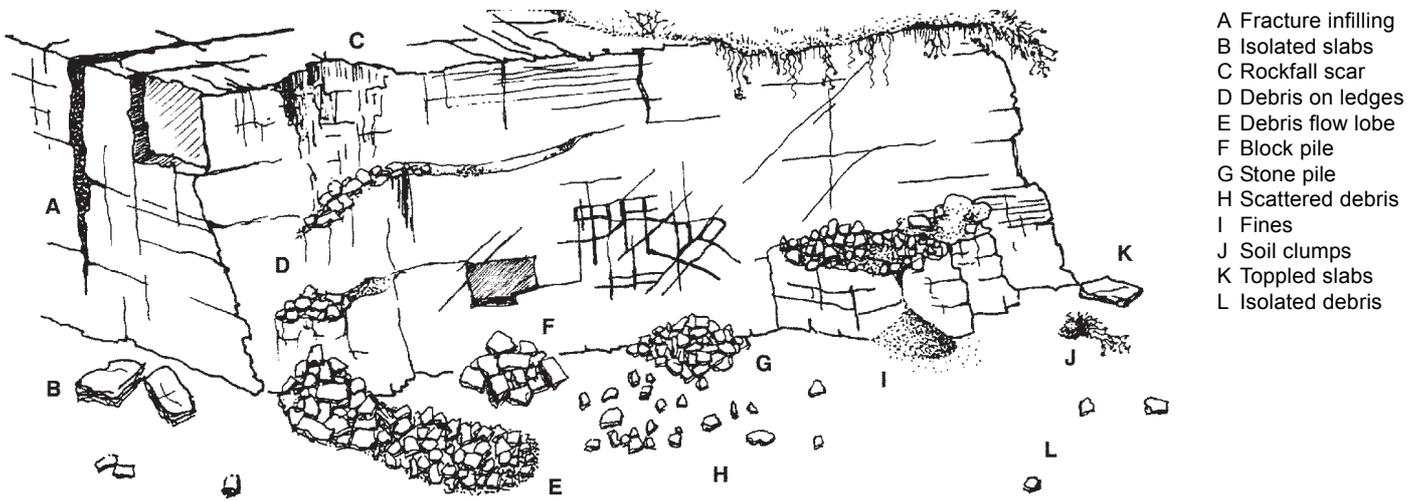
Figure 5: Depositional morphology due to deterioration.

<i>Fracture infilling</i> in particularly wide aperture fractures is relatively common. Several types of infill material can be identified including (i) fines resulting from the disintegration of fracture walls (effectively <i>in situ</i> infilling), (ii) fines washed into fractures from soil or detrital material, (iii) blocks dropped into fractures, and (iv) mineral precipitates (e.g. veins, healed fractures). The occurrence and properties of these different types of discontinuity infill are considered by Welsh (1994).

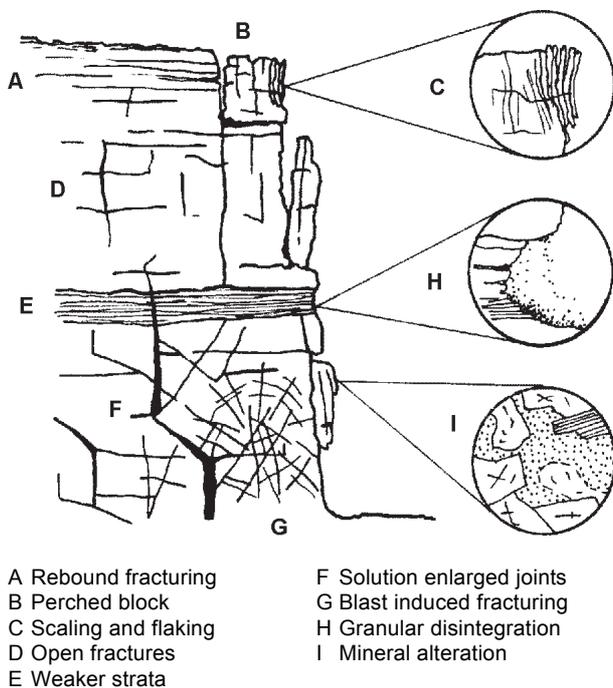
Figure 6: Deterioration process indicators.

Process indicators are features which give an indication of the cause of deterioration.

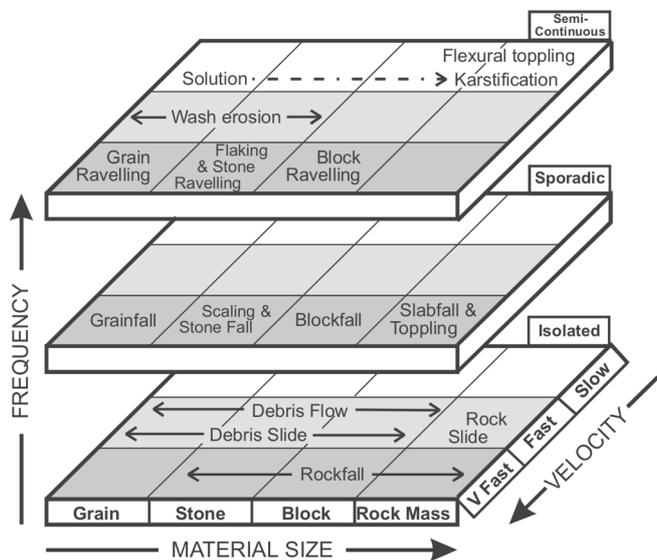
Figure 9: Engineering classification of deterioration modes for excavated rockslopes.

A classification of deterioration mode based on the field observations described is proposed (Figure 9). Modes are distinguished according to frequency of occurrence, relative velocity of movement and size of constituent material. Event magnitude can also be inferred from the deterioration mode. The classification is intended primarily

*Semi-continuous modes of deterioration:* Five semi-continuous modes of deterioration are recognised. (i) **Ravelling** is the frequent and semi-continuous fall of material. Three size divisions are recognised: grain ravelling (clay, silt, sand and fine gravel <20mm), stone ravelling (coarse gravel and cobbles 20 to 200mm) and block ravelling (boulders >200mm). Grain ravelling can be transitional with wash erosion (see below). (ii) **Flaking** is a form of ravelling involving the frequent and semi-continuous fall of material with a distinctive platy form, and occurs predominantly in fissile rocks such as shales and slates. (iii) **Wash erosion** involves detachment and transport of fine material entrained in surface water runoff. (iv) **Solution** is dissolution of soluble mineral grains and cementing material in aggressive, acid solutions, including rainwater. When this process affects the character of the rock mass it can be described as **karstification**. (v) **Flexural toppling** is a slow, progressive deformation and sliding of layered strata due to gravitational forces upon removal of lateral constraint.

*Sporadic modes of deterioration:* Three sporadic modes of deterioration are recognised. (i) **Fall** is the occasional fall of individual fragments. The same size divisions for ravelling are also used to give grainfall, stonefall and blockfall. (ii) **Contour scaling** is a special form of fall involving the infrequent exfoliation of thin layers of rock material formed parallel to the slope surface. (iii) **Slabfall and toppling** are the infrequent fall of large, tabular slabs and rotation of large prismatic blocks (typical 'a' axis dimension of 1m).

*Isolated modes of deterioration:* Three isolated modes of deterioration are recognised. (i) **Rockfall** is used as a specific term to describe the fall of many blocks of varying sizes in a single, identifiable event, and involve elements of freefall, slide, bounce and roll or a combination of these. (ii) **Debris flow** is the rapid transport of a mixture of coarse and fine particles in a partially saturated, grain-supported flow, and

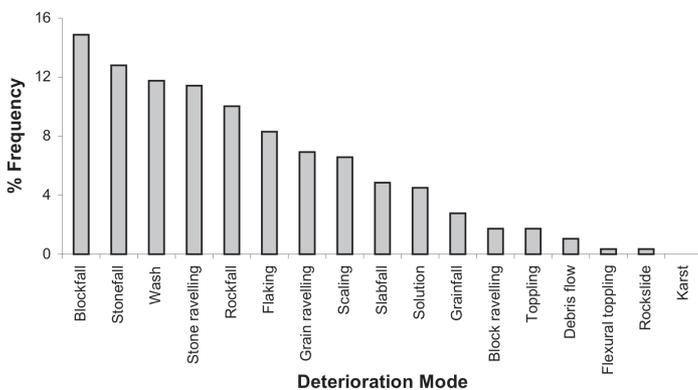
Figure 11: Percentage frequency occurrence of deterioration modes.

The percentage frequency occurrence of deterioration modes for all the slopes investigated is given in Figure 11. The total number of occurrences of deterioration modes was 289 and the total number of slope units was 106. The former value reflects the fact that for many slopes, more than one deterioration mode was in evidence. The chart shows that the fall of isolated fragments (both stone or block sized) is the most common mode of deterioration. Several modes which relate to material properties are also important, including wash erosion, grain ravelling and scaling, while the large scale modes of debris flow, rockslide and flexural toppling occur least commonly. While karstification occurred in slopes investigated as part of a wider survey of slopes in the British Isles, it was not identified in any of the slopes visited in the North West region but is included in the charts for completeness. Rockfall and stone ravelling occurred in around 10% of slopes and this is significant because these modes probably lead to the most rapid accumulation of debris and slope regression. They may not be the most hazardous modes, because even a single block can cause a fatality, but they are the most serious in terms of the volume of material involved.

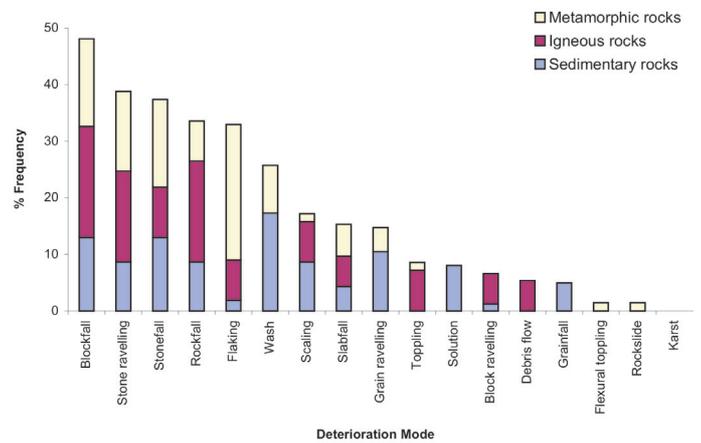
Figure 12: Occurrence of deterioration modes in relation to rock group.

Figure 12 shows the relative percentage frequency occurrence of deterioration modes for sedimentary, igneous and metamorphic slopes respectively. Two important findings are implicit in this chart. First, some deterioration modes occur with similar frequency for all rock groups. For instance, stone ravelling and blockfall are ubiquitous, being ranked most or second most common for all rock groups. Since these modes depend upon the presence of intersecting fractures, their ubiquity across all rock groups may reflect the preponderance of fractures, joints, bedding and blast-induced fractures regardless of lithology.

Second, some deterioration modes occur with much greater frequency in some rock groups than others. For example, in the sedimentary group, the relatively high rankings for wash erosion, solution and scaling are particularly notable, reflecting the greater importance of material breakdown. In the metamorphic group, flaking is dominant. This clearly reflects the large number of slopes with metamorphic cleavage, and a number of meta-sediments in which original thin bedding was strongly retained. This group also boasts the only occurrence of flexural toppling as a major mode, probably also a reflection of the importance of cleavage. The igneous group is dominated by deterioration modes which depend upon the fall or ravelling of stones or blocks defined by discontinuities (e.g. blockfall, rockfall and stone ravelling). The importance of modes based on material weathering (e.g. grain ravelling, grainfall, solution and wash erosion) is very low for this group, reflecting the high material strength and resistance to weathering.

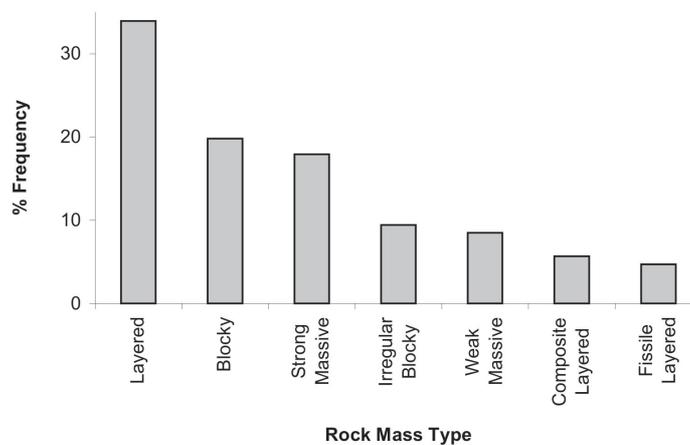
Figure 13: Percentage frequency occurrence of rock mass types.

The frequency distribution of rock mass types observed in the field investigation is given in Figure 13. The chart shows that layered rock masses are significantly more common than other types. However, since the frequency distribution is partly a reflection of the rockslopes investigated, it is helpful to consider the distribution of rock mass types with reference to the three rock groups, sedimentary, igneous and metamorphic. The chart in Figure 14 shows that there are clear relationships between rock group and rock mass type:

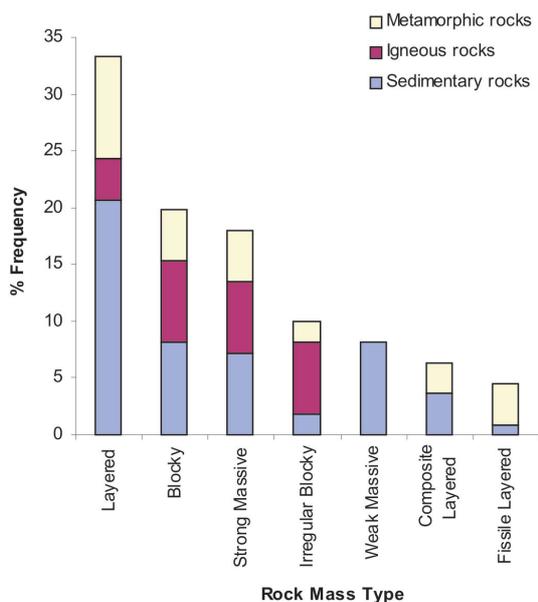
Figure 14: Occurrence of rock mass types in relation to rock group.

metamorphic rock masses. Layered slopes in igneous rock masses were usually dominated by parallel, *vertical* jointing. Igneous rock masses are dominantly blocky and irregular blocky. Many are also strong massive, indicating an absence of open fractures. This reflects the higher strength of igneous rock masses compared with the other rock groups. Some rock mass types only occur in one or two rock groups. For example, weak massive rock masses only occur in the sedimentary group and fissile and composite rock masses are absent from the igneous group. Irregular blocky rock masses are more likely to be igneous in origin, a reflection of the general absence of regular discontinuity patterns. The relatively high proportion of fissile rock masses in the metamorphic group is reflected in the increased role of flaking as a deterioration mode noted earlier.

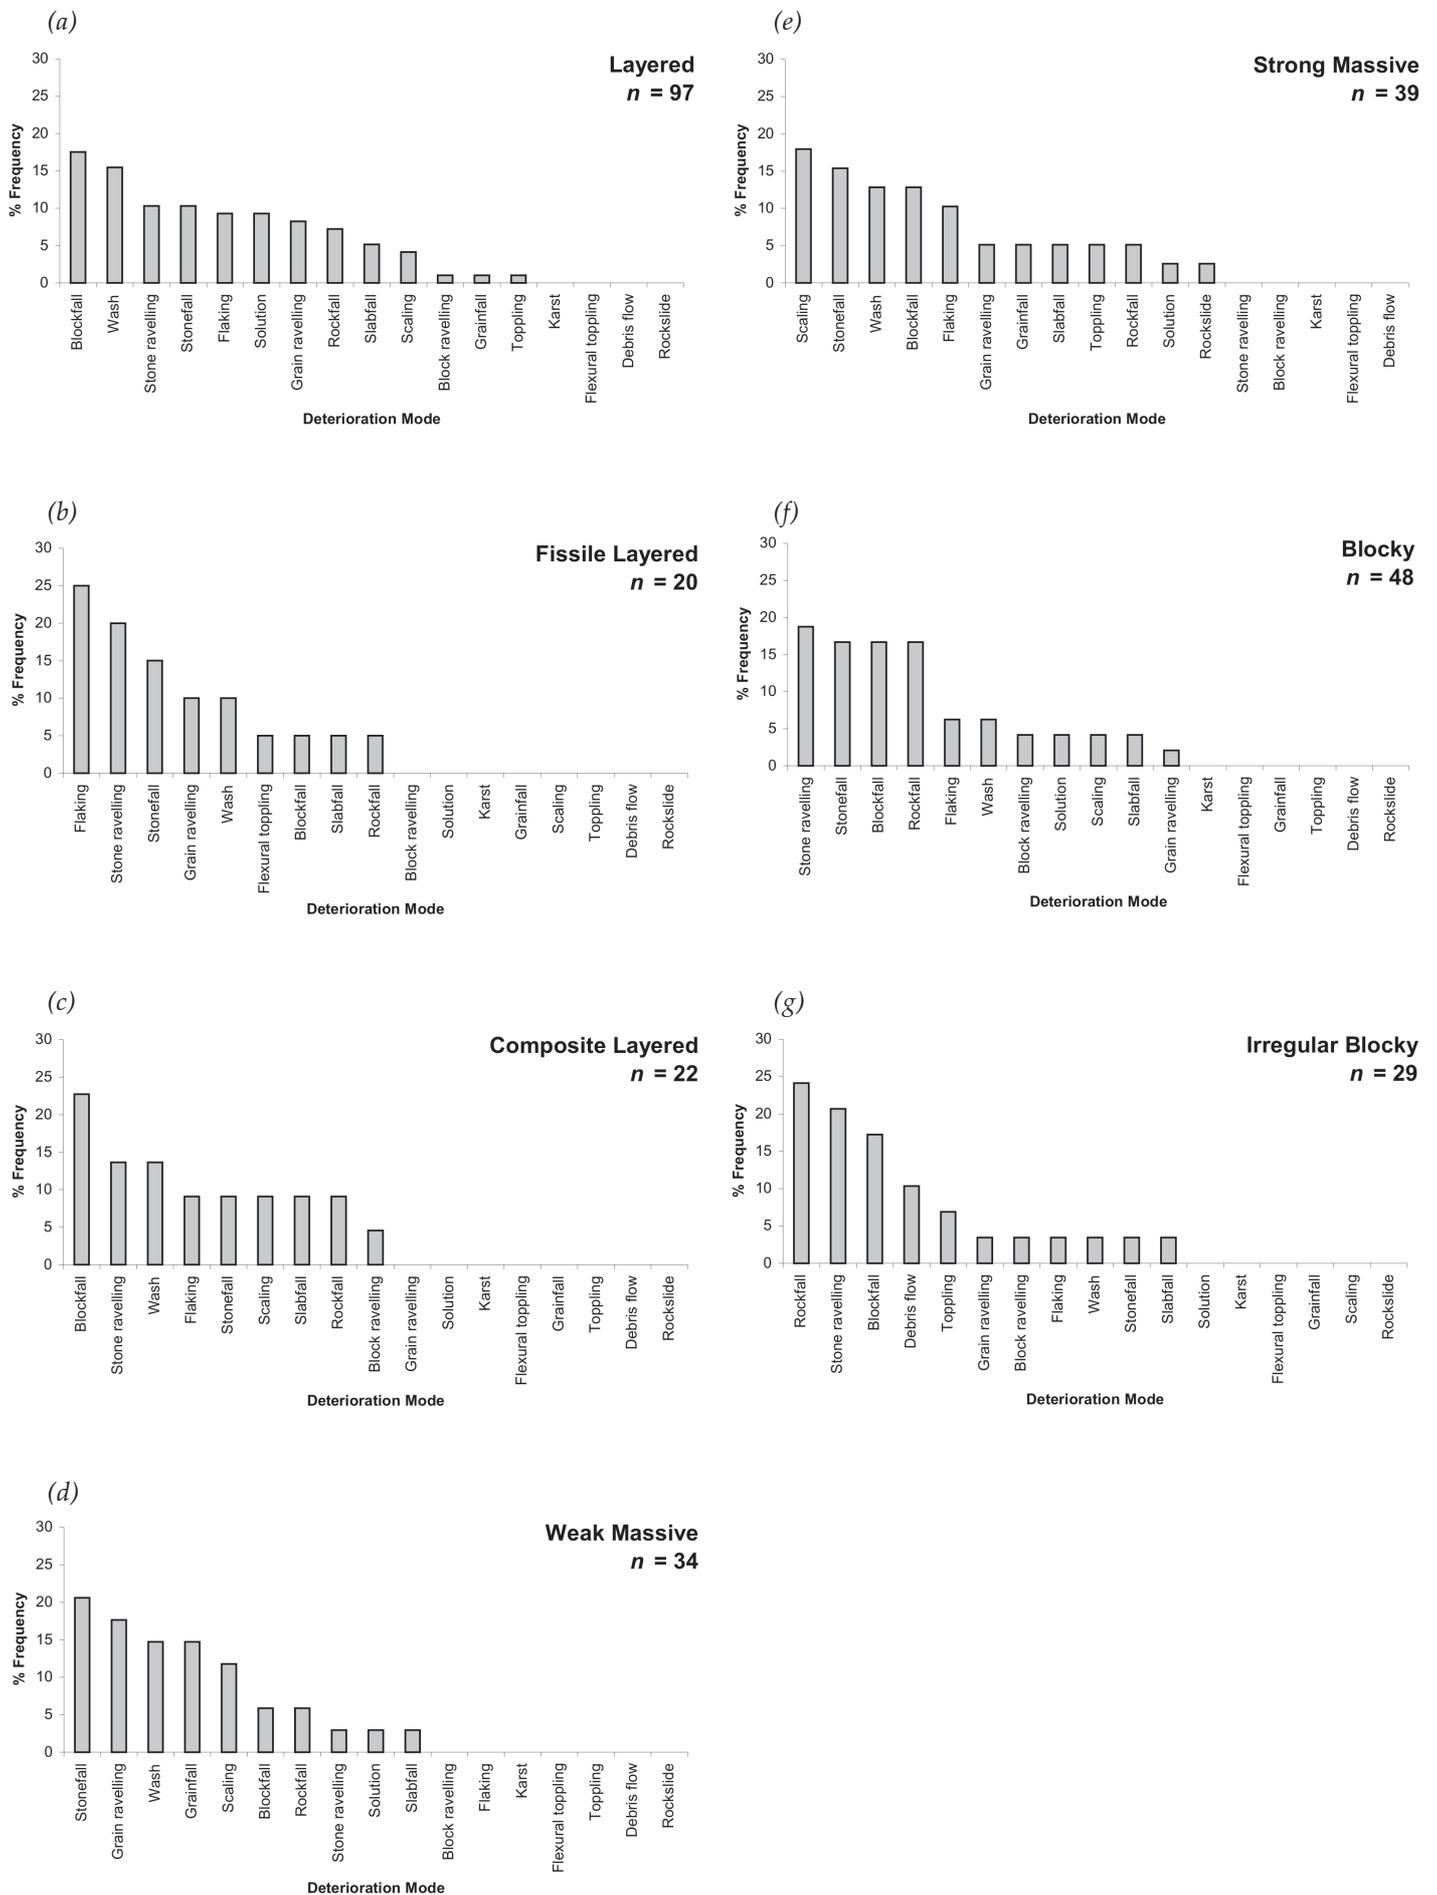
Figure 15: Occurrence of deterioration modes in relation to rock mass type.

The percentage frequency occurrence of deterioration modes for different rock mass types is given in Figure 15 (a to g). It is evident that some deterioration modes are closely associated with particular rock mass types, while others are independent. For example, weak massive rock slopes are dominated by deterioration modes where the focus is on material breakdown (e.g. grainfall, grain ravelling, wash erosion and scaling). Stonefall, the most frequent deterioration mode, is the exception to this, although stonefall does include very small fragments (>20mm). There is a similar emphasis on material breakdown for strong massive rock masses, though a slightly broader range of deterioration modes. In contrast, and as might be expected, blocky rock masses are most affected by mechanisms which depend upon the detachment of blocks. Common deterioration modes include stone ravelling, stonefall, blockfall and rockfall. In addition to these, toppling and debris flow occur in irregular blocky rock masses. This probably reflects the wider variety of particle sizes typically present in irregular blocky slopes. Layered and composite layered rock masses show a similar range of deterioration modes, with a mixture of discontinuity-dependent and material dependent mechanisms evident. Blockfall has a greater dominance in composite layered slopes and this probably reflects the greater opportunity for collapse of overlying blocks due to undermining of weaker material below. Fissile rock masses are dominated by the flaking mechanism as might be expected.

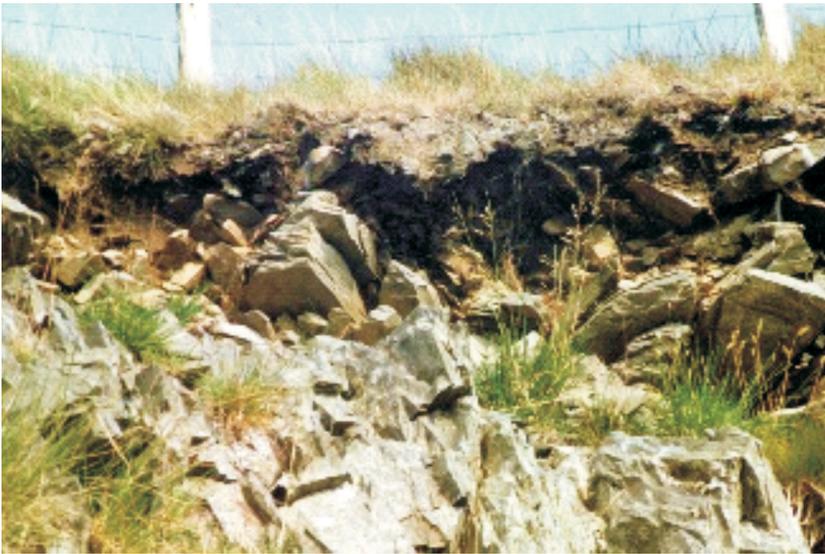
Figure 7: Risk of blockfall from beneath soil overhang (Wasdale Beck, A6).

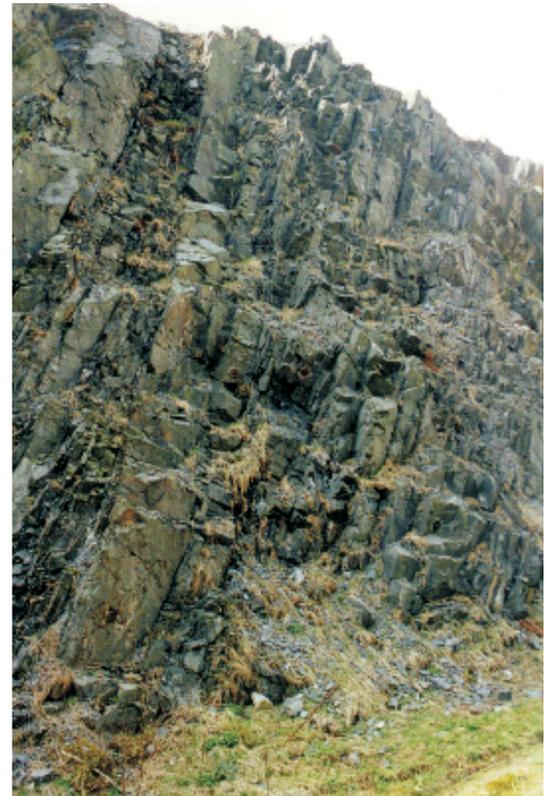
Figure 8: General ravelling and flaking of metasediments leading to debris accumulation (Dillicar, M6).
