Exploring Greater Manchester

The Mersey Valley from Didsbury to Chorlton Water Park and Jackson's Boat: transformed landscapes in an urban green/blue corridor.

The Nigel Lawson Memorial Walk

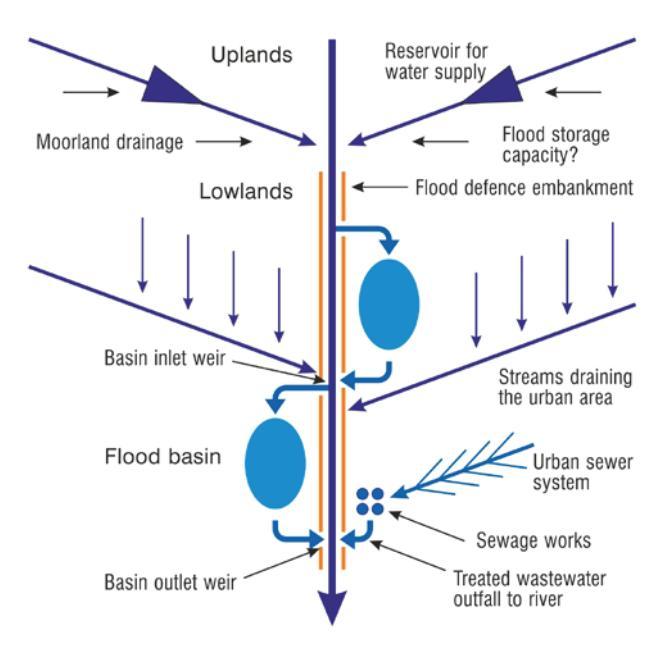
Figure 3: Schematic diagram of the major flood control work in the Mersey basin showing the upland reservoirs, urban drainage system, embankments and two flood basins, one of which is seen on this walk at Didsbury.

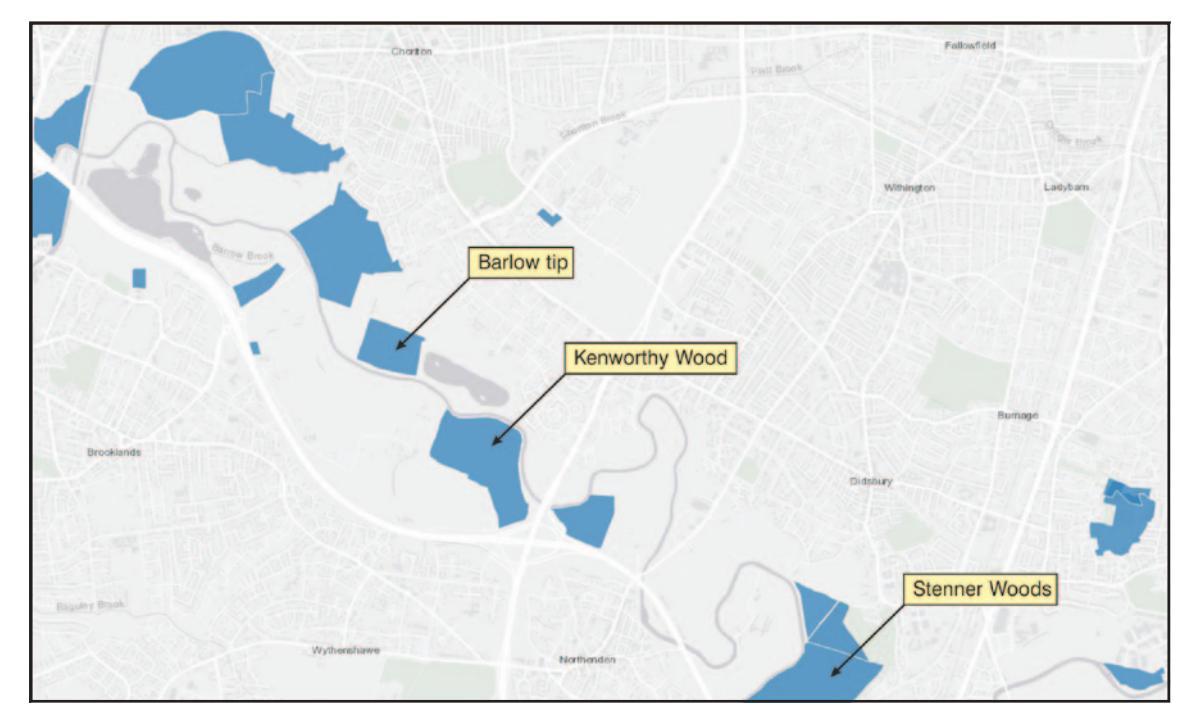
Figure 5: Map of the known Historic Landfill Sites in the Mersey Valley from Disbury to Sale showing those visited on this walk, from the Rivers Trust database. © *Ribble Rivers Trust 2021. Produced using data:* © *Natural England copyright 2021. Contains Ordnance Survey data* © *Crown copyright and database right 2021.*

part of the Mersey Valley (Figure 5). Prior to the 1956 and 1968 Clean Air Acts that established urban smokeless zones and restricted the burning of coal in both domestic fires and industrial furnaces, waste delivered to landfill sites contained a great deal of ash and clinker. These coarse-grained materials made the tips sufficiently permeable to be flushed by percolating rainwater and the leachate produced was

dissipated by dilution and dispersion. Consequently, the residue is now well composted and supports substantial trees. Evidence of the existence of these waste dumps can be found at the top of the steps of the boardwalk in the form of an old inspection chamber (Figure 6).

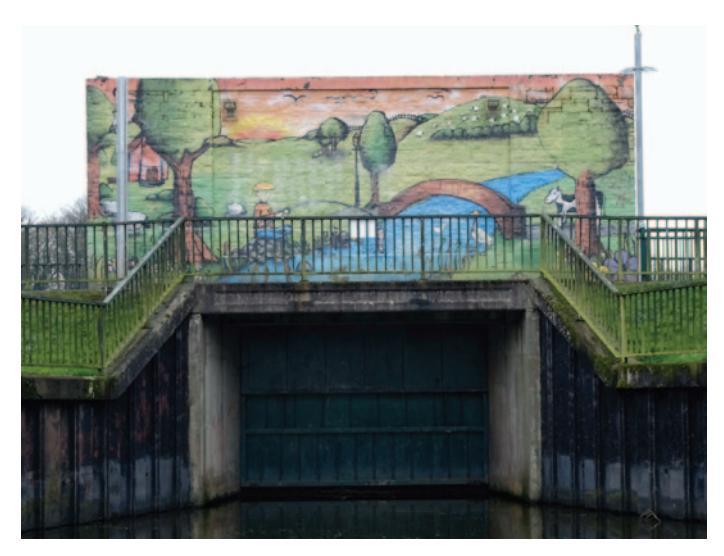
Figure 8: The sluice gate that allows water to flow out of the river. The artwork on the building housing the gate mechanism was designed by pupils of Parrs Wood Secondary School and painted by them with help from Unity Arts as a project to reduce vandalism and graffiti.

> Further along this track bear left along a narrower path that heads down to Millgate Lane. Cross the lane and continue along the path with a hawthorn hedge on your right and the flood scheme inlet channel on your left. You will soon reach the sluice gate that can be opened to allow water to flow from the river into the Didsbury Flood Basin (Figure 8).

The Didsbury (upstream) temporary storage basin comprises most of Fletcher Moss Park (east basin) and Withington golf course (west basin) and is dammed in the west by Palatine Road. At times of flood the sluice gate at Millgate Lane is opened to allow water to pass from the river into the temporary storage basin, thereby lowering the level of the water in the river. As the basin fills and the river lowers, the outlet sluice about 2.5 km downriver at Northenden weir is opened to allow water to pass out of the basin and back into the river.

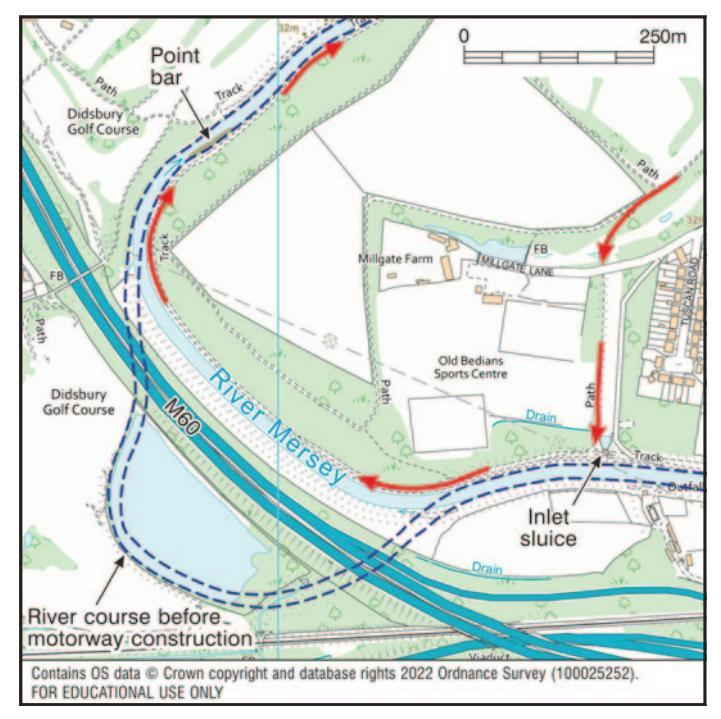
Figure 9: Diversion of the River Mersey during construction of the M60 motorway.

The channel here is not the river's natural course, the river having been diverted when the motorway was constructed to avoid the need for bridges over the former river channel (Figure 9).

As the river bends round to the right there is a fine example of a point bar on the near side (Figure 9) which

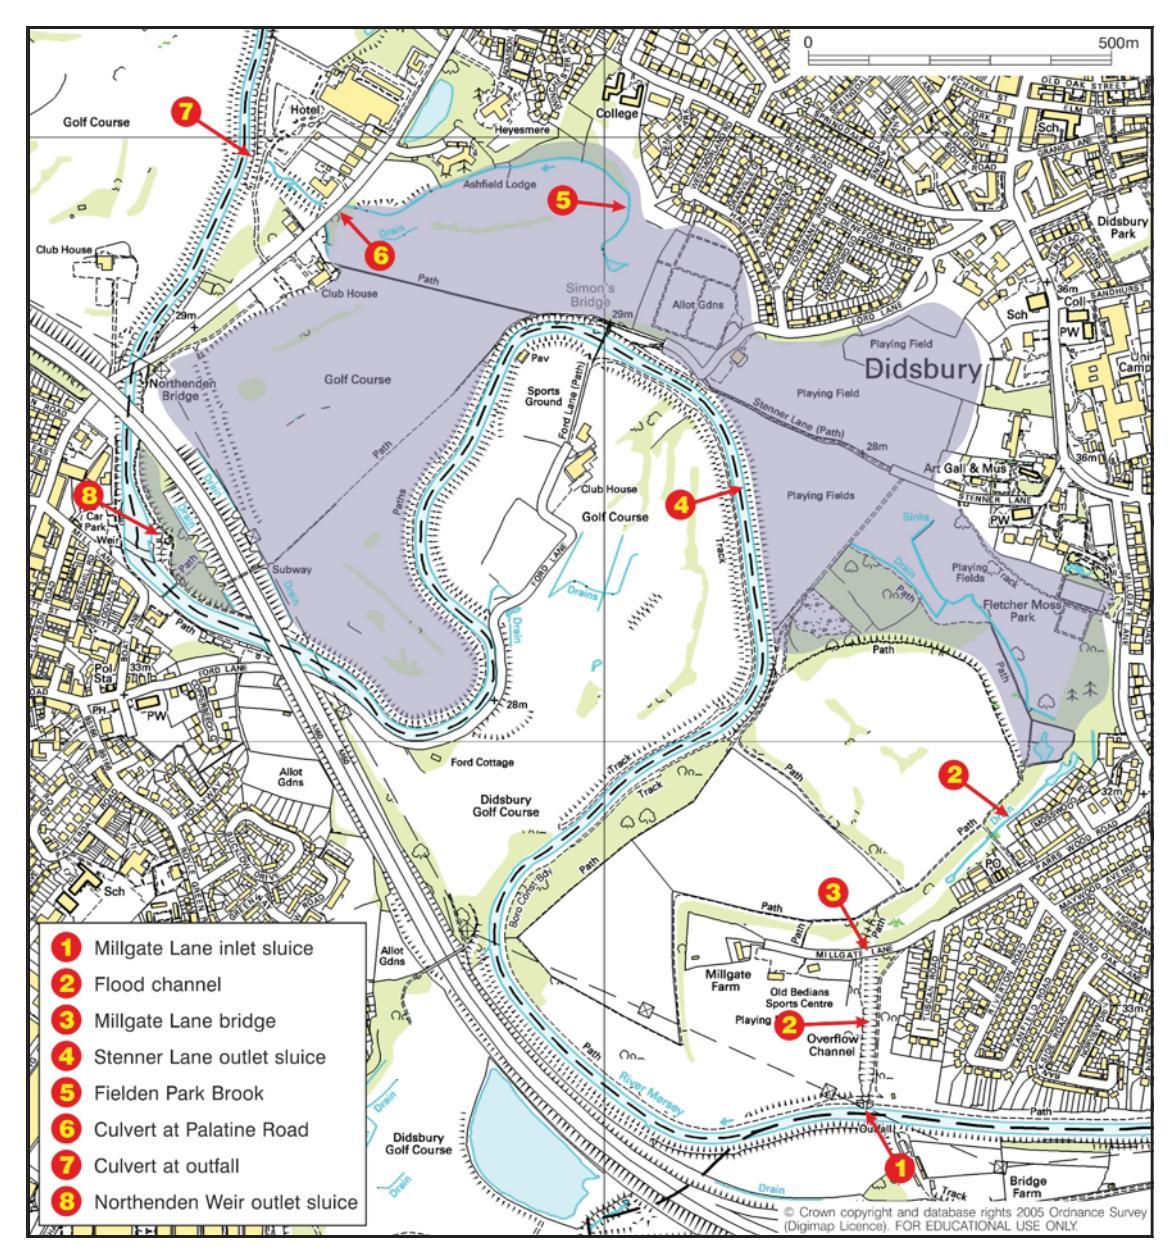
Figure 11: Didsbury temporary flood basin.

As explained earlier two flood storage basins were constructed in the early 1970s, one here in Didsbury and another at Sale Water Park. The land to the north of the river at this point is the eastern side of the Didsbury Flood Storage Basin and is also used by Didsbury Toc H Rugby Club and contains Withington Golf Club's course.

part of the basin at Fletcher Moss Park (north of Point 2 on Figure 11) to the western part at Withington Golf Course and thus backing up and potentially flooding the cottages on Stenner Lane (Figure 11). Following an original proposal to put a channel through the allotments, which would have taken away 40% of their area, the eventual solution was the construction of a flood wall at Stenner Lane and a new outlet sluice from the basin to the river at a total cost of over £400,000 (Figure 12). However, during the flood events of 2021 and 2022, this sluice proved totally ineffective and the playing fields and club building at Didsbury Toc H were cleared of water only after 3 days use of heavy pumping gear by the Environment Agency.

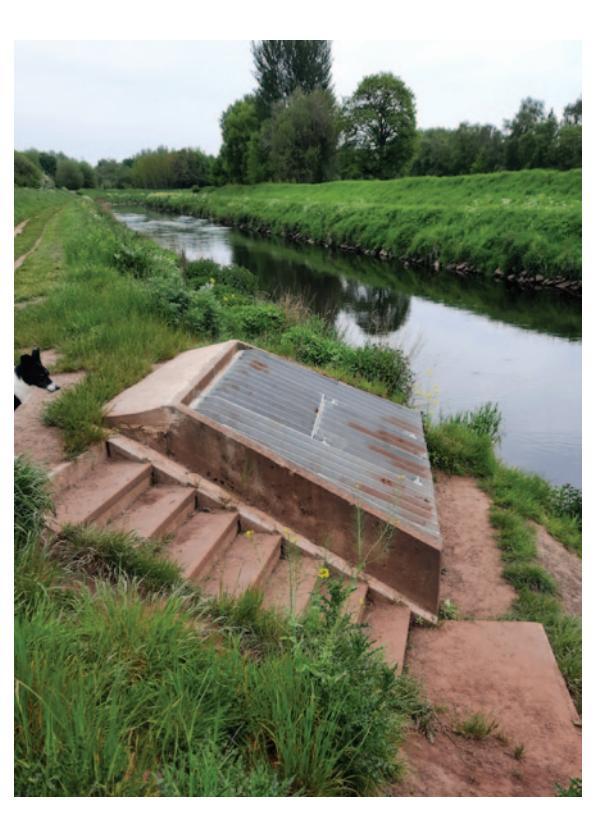
Figure 12: Stenner Lane sluice gate into the Mersey at Fletcher Moss.

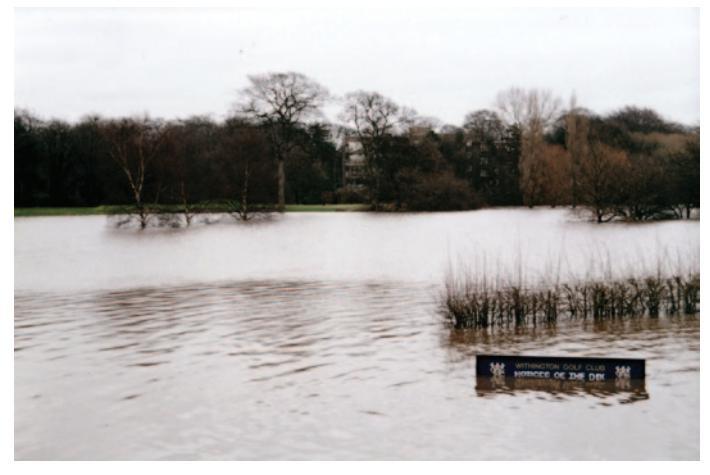
Figure 15: Flood water in the storage basin at Withington Golf Club in December 1991.

The Golf Club was founded in 1892. Prior to that date the area was used as grazing land. It was divided up into around 20 fields of varying size, most of which were detached parts of farms lying elsewhere in the township of Didsbury. The principal landowners and tennants in 1845 are shown on the Tithe map (Figure 14). At that time the embankments would not have been as high as the are today and there would have been sluices to deliberately flood the fields as a means of introducing fertile fluvial sediments. Since the embankments were raised and the course was incorporated into the flood alleviation scheme the sluices at Millgate Lane have been opened 3 times, firstly in December 1991, and then in January 2021 and February 2022 (Figure 15).

Just below Northenden weir, on the north bank of the river, water held in the Didsbury temporary flood storage basin (Figure 15 above) is returned to the river through several culverts under the motorway embankment and then through a sluice into the river (Figures 16 and 17).

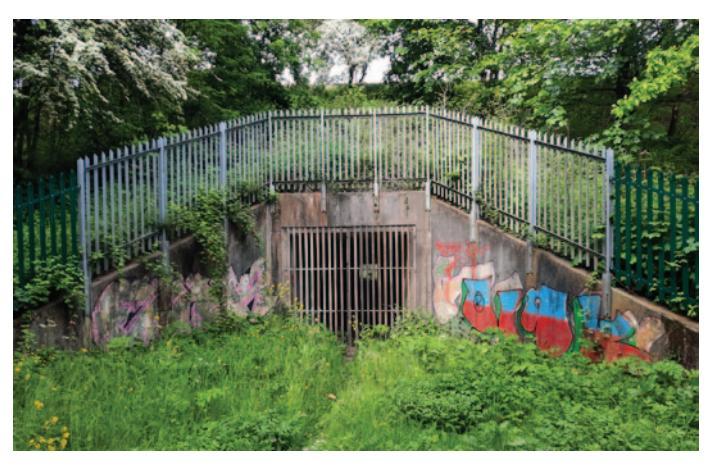
Figure 16: Culvert under the motorway embankment.

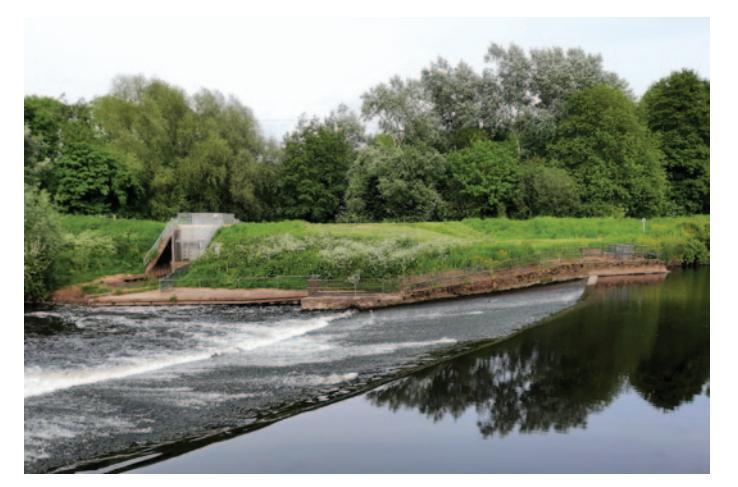
Figure 17: The flood basin outflow sluice and the fish ladder at Northenden.

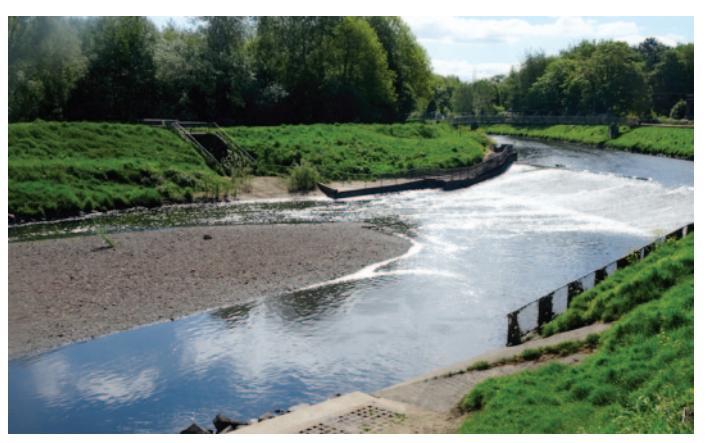
Figure 19a: Northenden weir and sediment bar in June 2020.

The photograph below (Figure 19a) was taken early June 2020 when the river was exceptionally low following a two month period with virtually no rainfall and clearly demonstrates the build-up of river sediments below the weir, which are deposited when the flow of the river slows down. However, at high flows (Figure 19b) the weir and gravel bar cannot be seen.

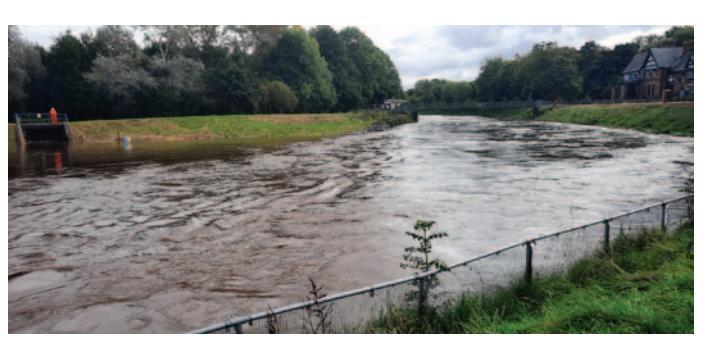
Figure 19b: Northenden weir in October 2020 with the river at high flow. The water covers the weir and sediment bar.

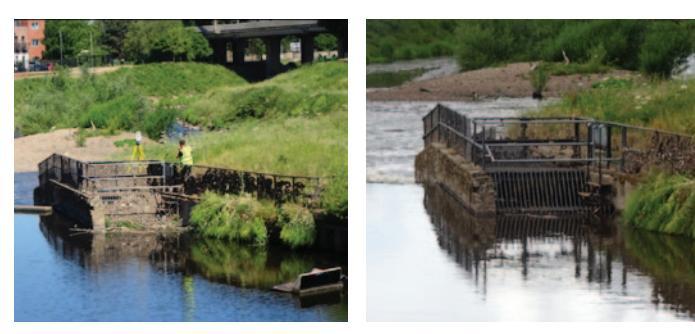
Figure 20a (left): Fish ladder at Northenden weir at low water prior to debris removal. Figure 20b (right): The fish ladder after removal of debris.

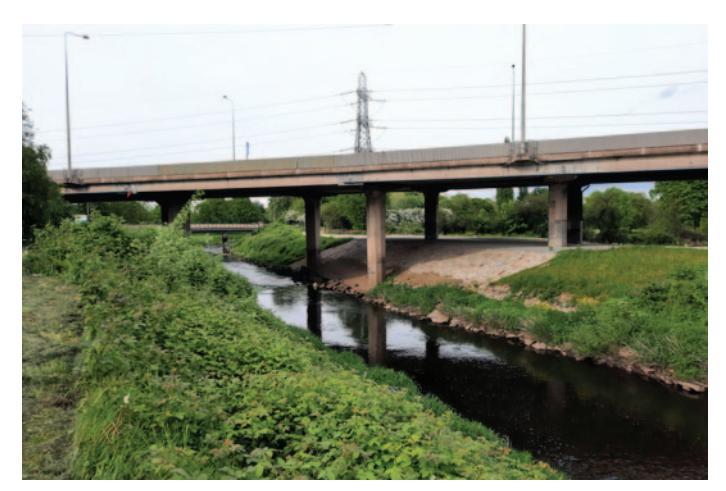
Figure 22: The M60 viaduct crossing the Mersey near Palatine Road.

to build a motorway through the Mersey Valley – partly across the actual flood plain of the river – was the need to keep it above the flood level of the river. To achieve this, the motorway was built mainly on a high embankment with only short lengths in cuttings.

The flood plain itself is made up of post-glacial materials such as consolidated alluvium and terrace gravels. Below these deposits, the 'solid' rocks of the Triassic system were found at depths of from less than 6 metres to more than 18 metres. Dealing with these recent deposits was a critical part of the motorway project, both how to use them as a source of fill and how to construct an embankment up to 12 metres high without causing failure either of the embankment or within the weak alluvium below.

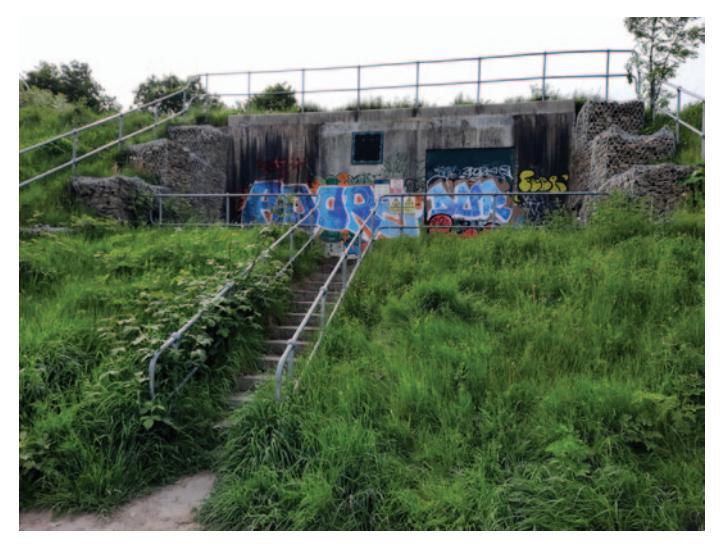
Figure 24: Settlement tanks at Darley Avenue.

Point of interest 8: Darley Avenue settlement tanks About 1.2 km further downstream along the riverside path a concrete structure with a set of steps down the path can be seen (Figure 24). This is part of the sewer overflow management system for urban drainage in the Mersey River catchment. Beneath the open area around the structure are large concrete tanks into which stormwater from the combined sewers draining the local area flows. The purpose of the tanks is to hold the storm water and allow the solid matter entrained within them to settle to the bottom of the tanks. Excess water normally flows through a connector sewer to the nearest sewage works. However, when storm flows exceed the capacity of that connector sewer and the tanks become nearly full, the water at the top of the tank will flow through an outlet pipe into the river. The settling tanks help to reduce the amount of contaminants entering the river. The solids form a sludge at the bottom of the tank which is periodically removed. These tanks were substantially enlarged around 2010. United Utilities recognise that further improvements to minimise storm sewage discharges are required as part of the continuing campaign to improve the River Mersey ecosystem.

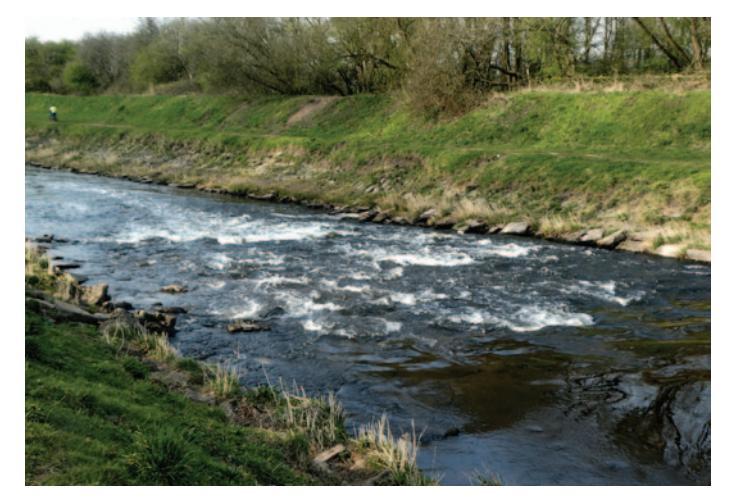
Figure 29: Riffle in the River Mersey near Kenworthy Wood.

In the river channel an artificial riffle is visible, with turbulent flow over rock particles (Figure 29). The rocks in the channel divert water and increase the rate of flow locally, allowing more oxygen to be dissolved, so improving conditions for aquatic life. As the water depth over the riffle is less than in the reaches above and below it, the water temperature changes and the increased flow-rate means that sediment is removed more rapidly. You will see several other riffles along the river but may ask whether their spacing is sufficiently close together to produce the desired outcomes for aquatic ecology (Newbury, 2013).

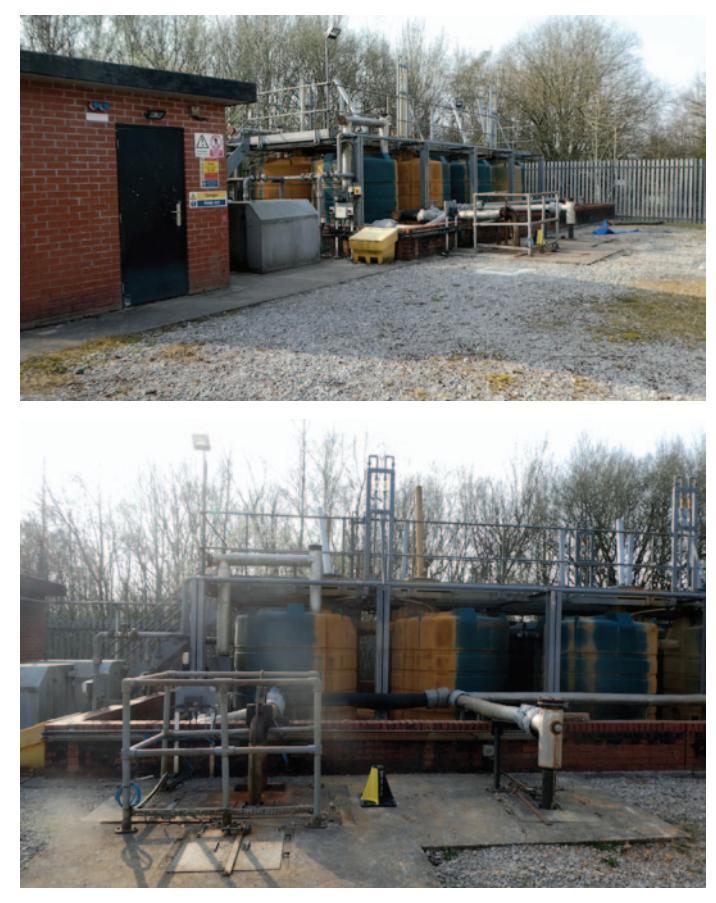
Figures 36a and b: The landfill gas treatment plant at Barlow Tip.

At the flat summit of the former tip, the ground becomes so damp that the vegetation is almost like that of a wetland. Beneath this damp surface and the underlying clay capping are substantial amounts of organic waste material that continues to decompose and release gases created by the actions of microorganisms within the landfill. The complex mix of gases from landfills typically comprise forty to sixty percent methane, with the remainder being mostly carbon dioxide and with trace amounts of other volatile organic compounds (VOCs). These gases are treated at the plant at the north-western end of the tip (Figures 36a and

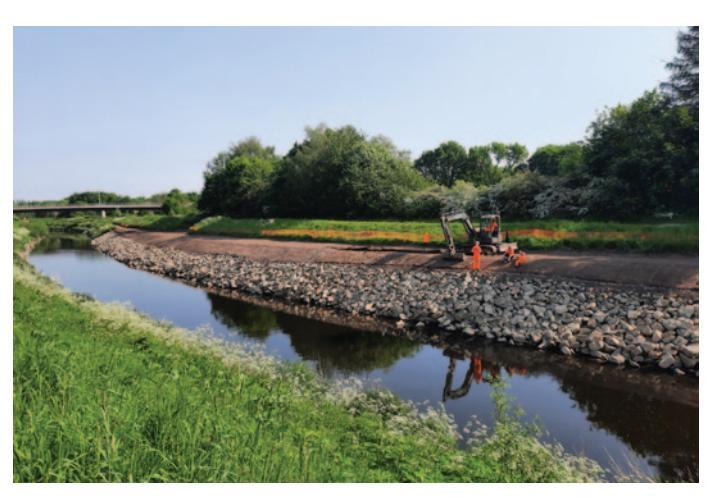
Figure 39: Remedial work on the river bank (viewed from the south bank in May 2023).
