Exploring Greater Manchester

a fieldwork guide

Stretford Meadows and Urmston Meadows: landscapes of the Anthropocene

Consequences of urbanization and new opportunities for urban nature.

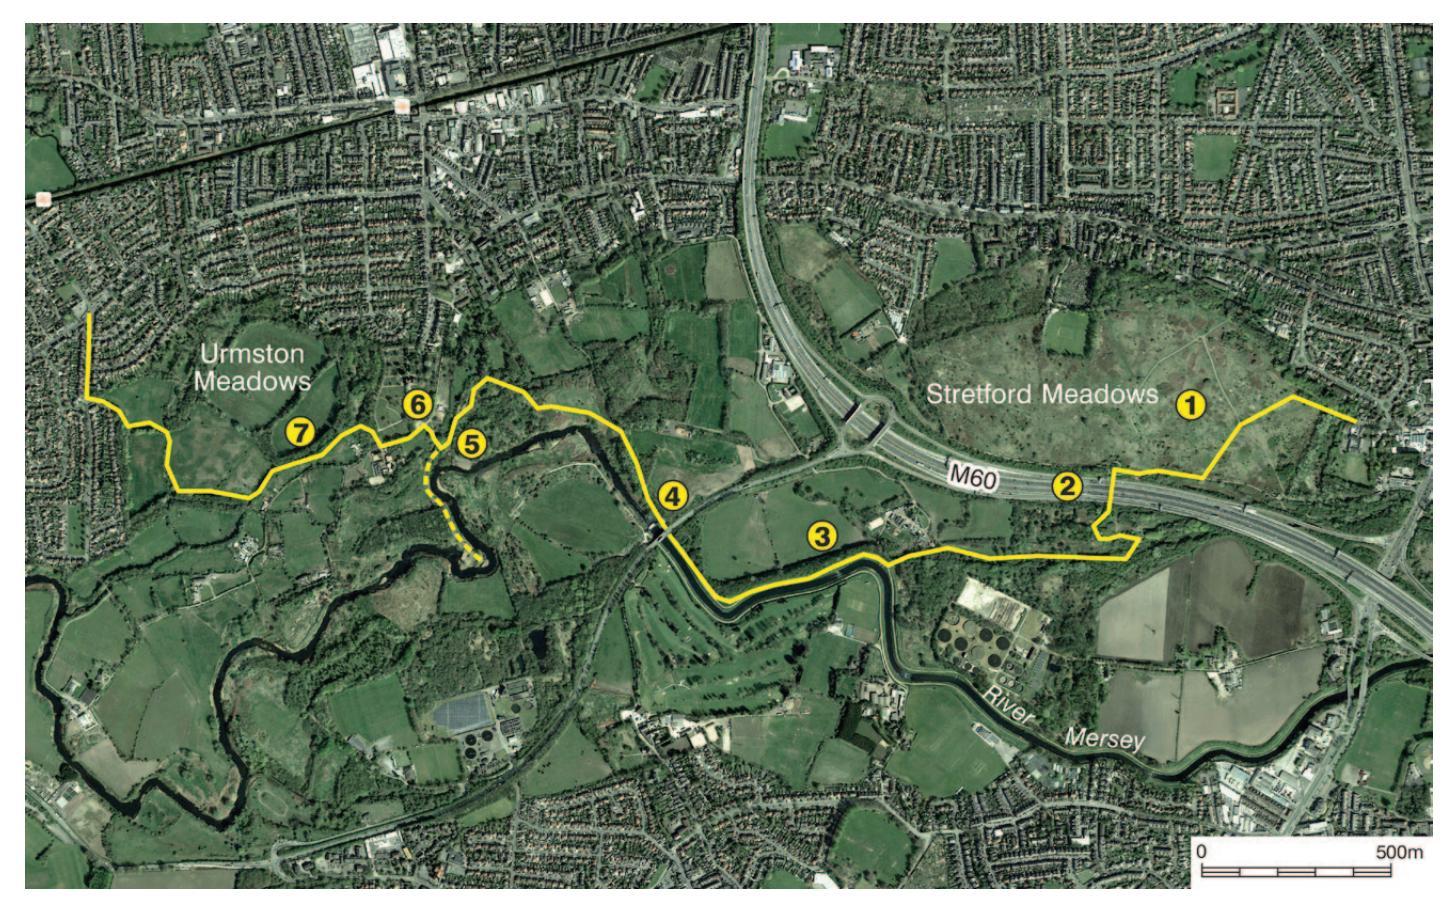
Figure 1: Map of the route from Poplar Road in Stretford to Urmston Meadows, showing the positions of the stops mentioned in the text (image©*Google Earth).*

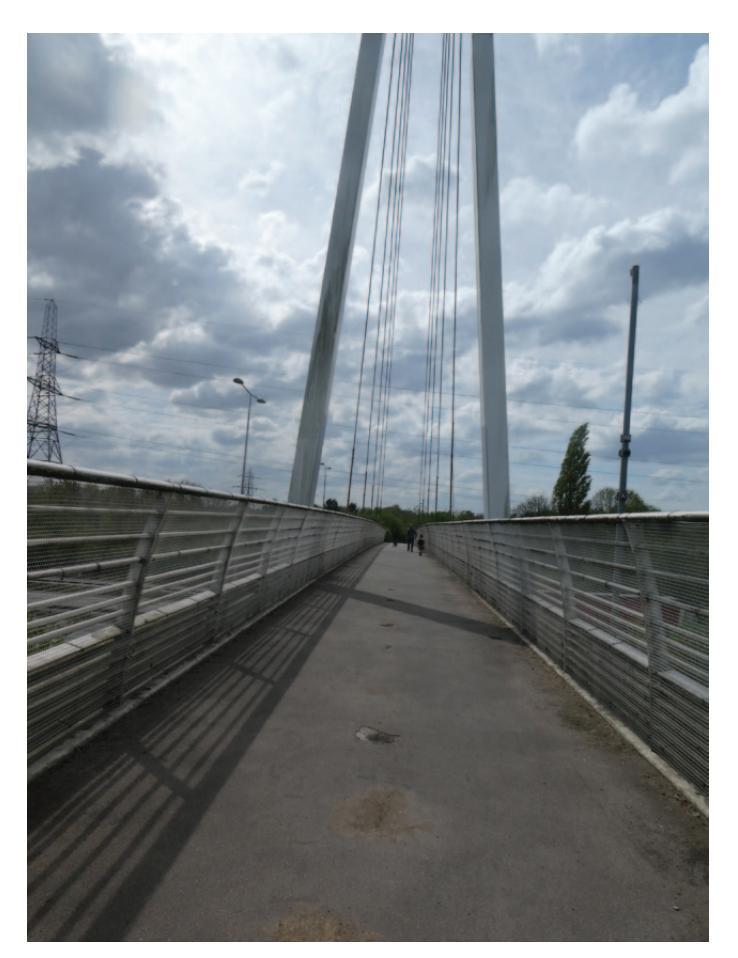
Figure 4: The Pegasus Cable Stayed Footbridge across the M60.

This cable stayed pedestrian bridge (Figure 4) was constructed in 2006 when the motorway was widened. It replaced a gloomy subway under the original motorway. The bridge offers good views over the motorway and the surrounding area.

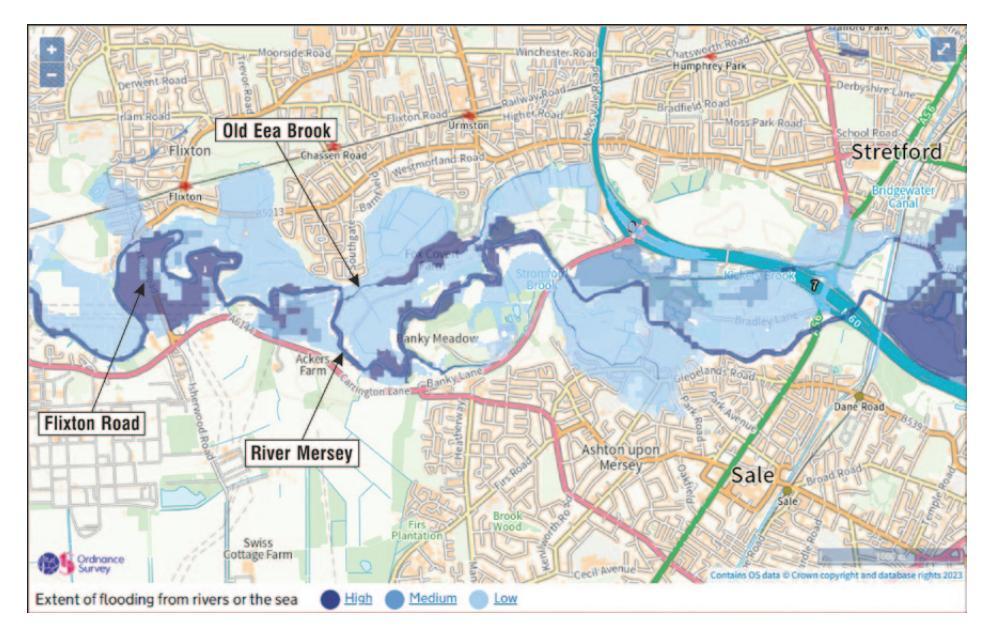
Figure 8: Flood risk map for the Mersey Valley from Flixton to Stretford. Note how the high-risk zone covers Flixton Road, running south from Flixton across the floodplain. Floodwaters across that road may lead to its temporary closure every one or two years (Figures 9 and 10). [These locations are beyond this walk but are included to show how floods disrupt daily life.]

From the riverbank, looking across the river you can see the sight screens and buildings of the Ashton-on-Mersey Cricket Club (Figure 7), which are in a floodable area. However, the river embankments protect most of the playing fields and the nearby Ashton-on-Mersey Golf course from all but the most severe floods (Figure 8).

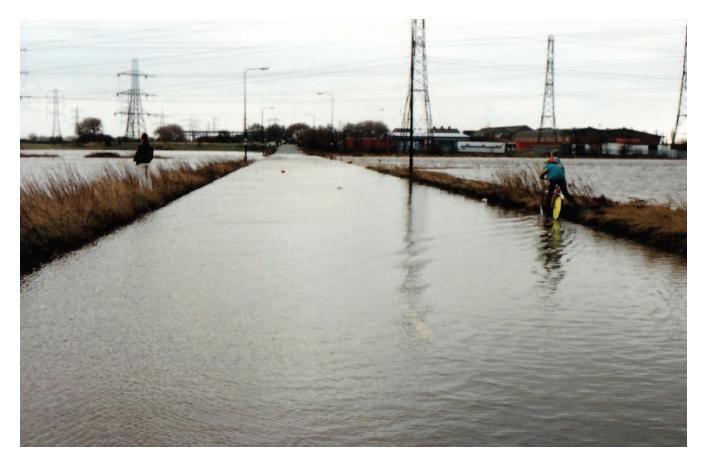
Figure 9: View from Flixton Bridge of the road flooded in 1986, note the flooded fields on both sides of the road.

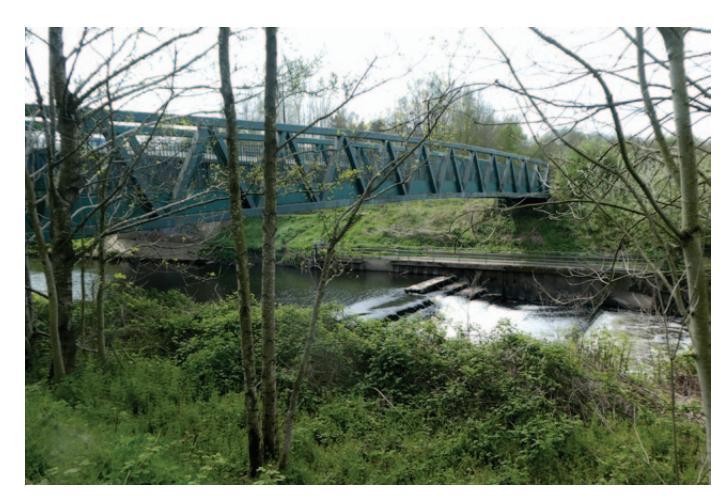
Figure 11: Ashton Weir and the Millennium Footbridge.

The brick structure houses the Ashton Weir river level recording equipment that provides a continuous record of the river flow. To check the river level on the day of your visit and how it has varied in the five previous days, go to: <u>https://check-for-flooding.service.gov.uk/station/5008?direction=u</u>

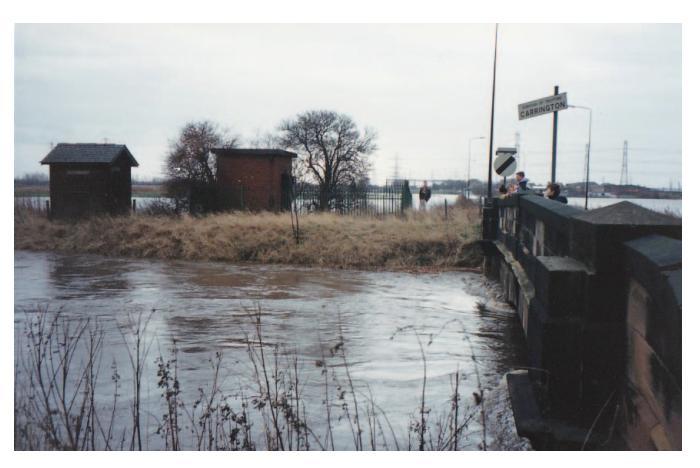
Figure 10: The River Mersey at Flixton Bridge at the same time.

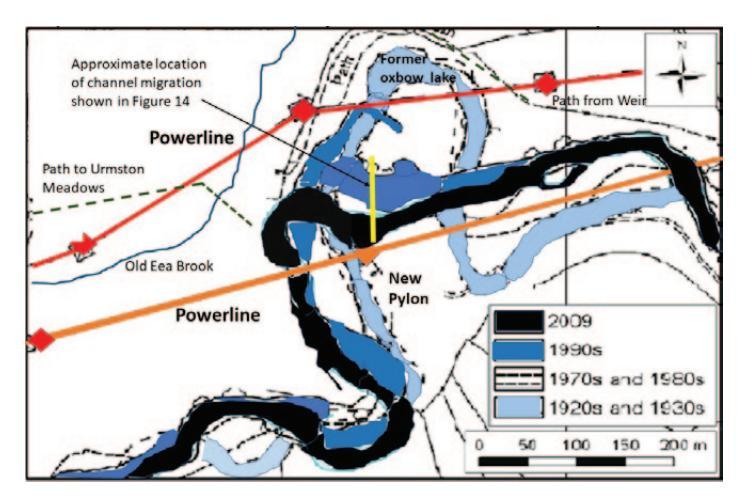
Figure 12: Changes in the position of the Meander of the Mersey at Urmston (adapted from Da Luz et al., 2015).

The rivers running across the low-lying areas west of the Pennines all have meanders that continue to shift, but this meander on the Mersey, just downstream of the builtup area of Greater Manchester, has changed particularly dramatically since the 1970s (Figure 12). Since the 1920s the former meander loop has shifted a little downstream. In the 1980s the outer bank of the loop near the footpath was still eroding, with rotational slumping of pieces of the bank. However, the initial cut off began to develop before 1980 and was completed during the following decade. In the 1980s the old meander loop still had water in it and had all the characteristics of a cut-off ox-bow lake. Since then, the

main channel has continued to shift southwards, eroding the southern bank so much that an electricity transmission line pylon had to be replaced by a new one further from the river. That replacement pylon is now at risk as the river channel continues to migrate southwards (Figure 14). In the 1990s, the concrete bases of the original powerline could be seen in the middle of the changed main channel of the river.

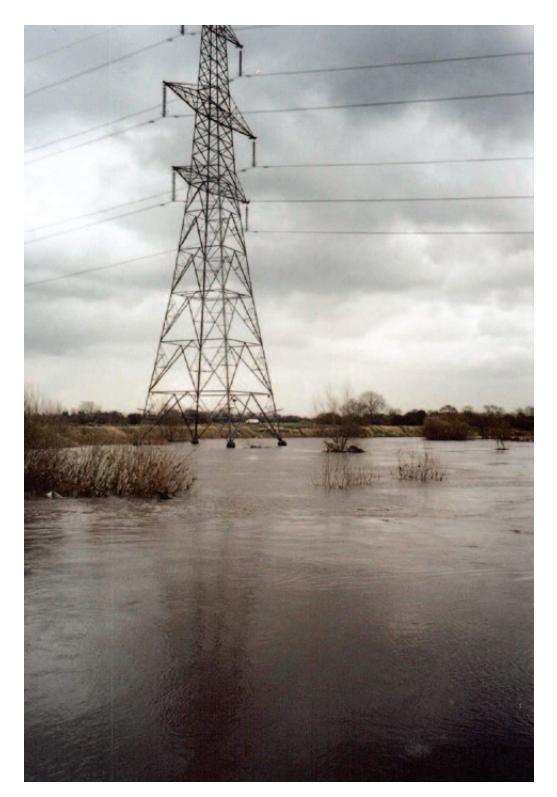
Figure 13: A pylon surrounded by water in the 1996 flood at the Urmston meander. Such floodwaters deposit fine silt on the surface of the floodplain, helping to build up the layers of sediment into which the river is now eroding.

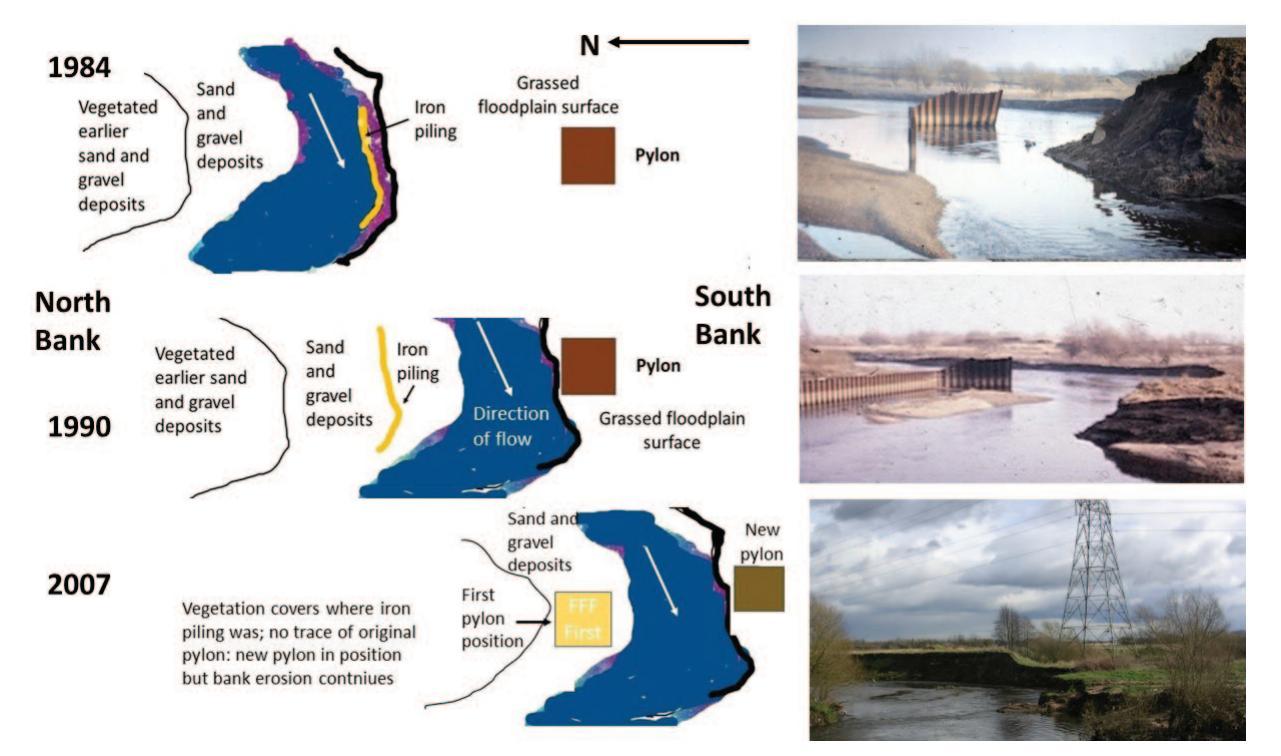
Figure 14: Diagram to show the changing position of the Mersey low flow channel and the erosion of the south bank of the Urmston meander between 1984 and 2007. In the first decade the iron piling that was close to the south bank in 1984 became part of the north bank. All traces of the original pylon disappeared and further erosion shifted the low flow channel further south and the iron piling had become incorporated into the expanded gravel bar on the north bank. Further erosion southwards in the next 17 years saw vegetation covering the area where the iron piling was and the southern bank getting closer to the replacement pylon. What is striking about this situation is that the structures created by humans remained in place while the river shifted relentlessly towards the south. The channel shift is a natural process, but its speed and magnitude are related to what humans have done to the river and its tributaries upstream.

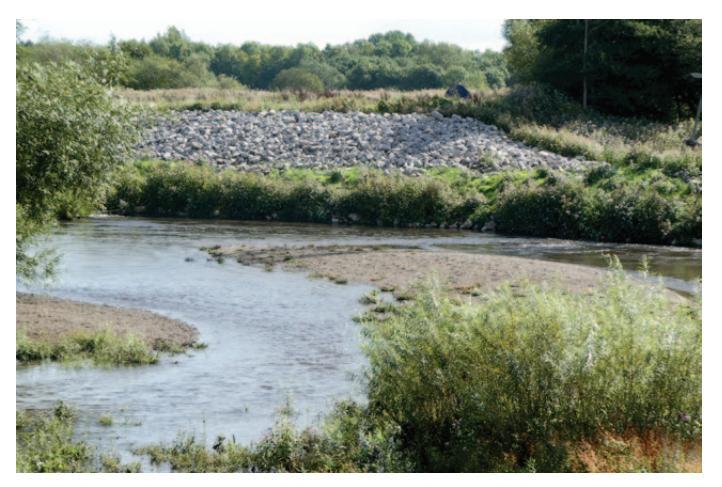
Figure 15: Bank protection work in 2018.

Protecting the pylon is critical for both safety, electricity supply reliability and cost (around £0.5 million to relocate a pylon, Da Luz *et al.*, 2015). Concern has been expressed that as climate change produces severe storms more frequently, the bank erosion here may threaten not only the present pylon but others along this stretch of the river between Ashton Weir and its confluence with the Ship Canal. Additional bank protection work was begun in 2017; this may have to be reinforced in the near future.

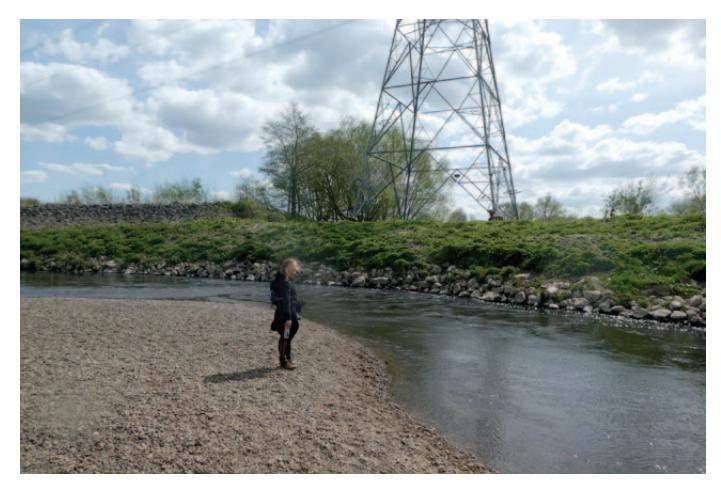
Figure 16: State of the bank protection work in April 2022 showing the proximity of the present pylon to the edge of the bank.

This new, replacement pylon has been identified as a problem in an assessment of possible future erosion under a changed climate. Arguing that the electricity network sector cannot quantify the future erosion risk posed to towers, and the vulnerability and resilience of power line assets to future changes in the frequency and severity of storms, Feeney *et al.* (2022) examined this reach of the Mersey. Their modelling showed that the present pylon is threatened by

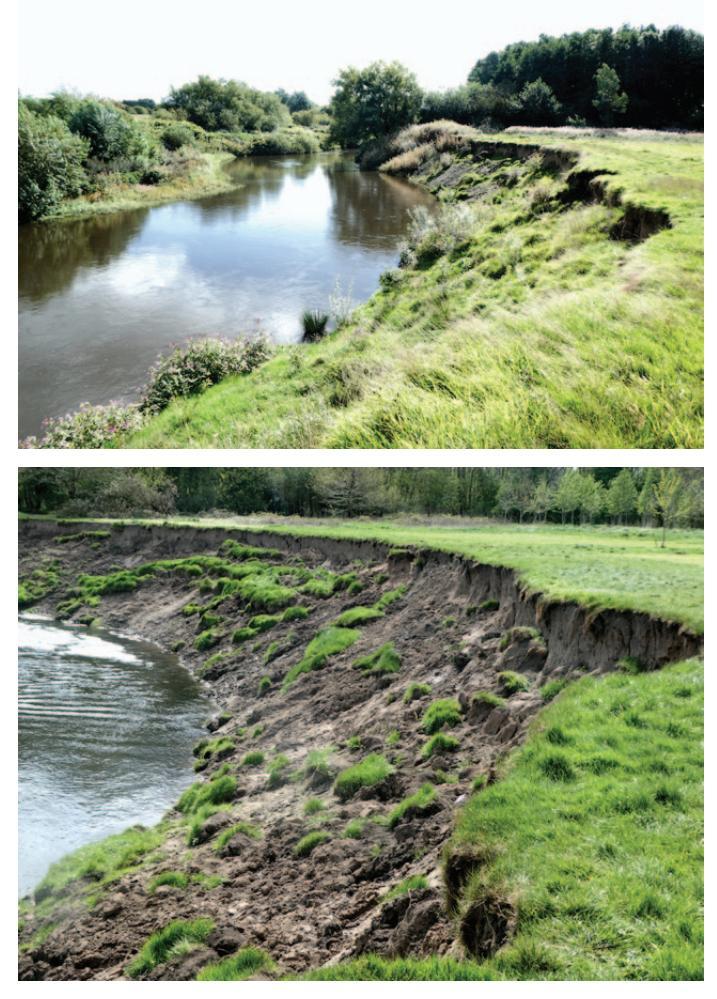
Figures 17 and 18: Slumped soil and turf at the north bank Urmston meander in 2012 and 2022 (The bank has receded almost two metres in ten years).

> After observing the pylon and related channel shift, continue downstream on the north bank, going round the bend to where you can see the eroding edge of the north bank (Figures 17 and 18).

Here the process of bank erosion is clearly visible. The river undercuts the bank, with active slumping of pieces of the original grassed meadow which slide downslope towards the river. Much of the bank has become overgrown by the invasive Japanese Knotweed and Himalayan Balsam.

This is a vivid reminder of how channels change under natural conditions. However, it is highly probable that two factors affect the magnitude and rate of bank erosion here:

- the rapid runoff of extreme storm water from the paved and roofed surfaces of the city upstream and the swift passage of the storm flows through the embanked reaches within the city which creates great erosive energy in the flows; and
- 2) the much reduced sediment sources in the embanked reaches of the river immediately upstream which are generally vegetated and protected. With relatively little sediment to be entrained until below Ashton Weir, the river has a high sediment carrying capacity in this reach at Urmston and readily erodes the unprotected banks.

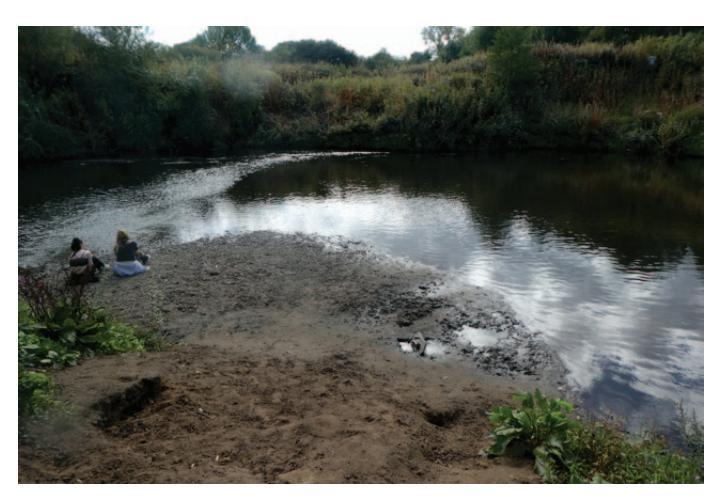
Figure 20: The "Urmston Beach" gravel bar on the inside of the next meander curve of the Mersey at Urmston.

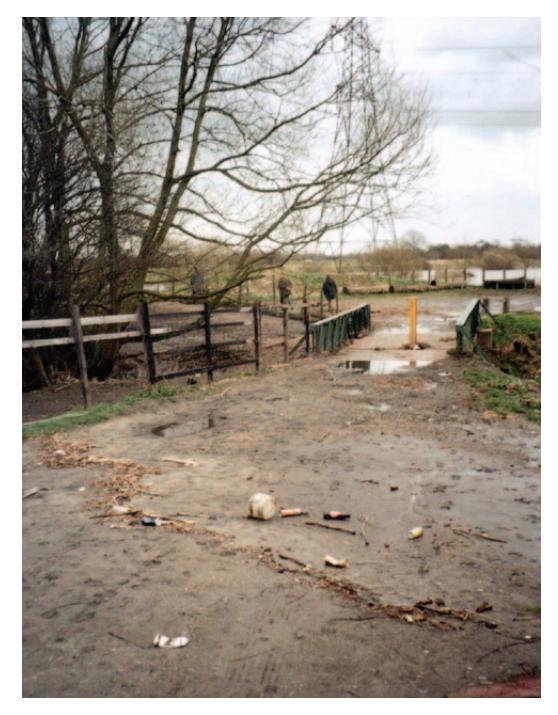
Figure 21: View from the access road towards the Old Eea Brook bridge with the River Mersey at high flow beyond after a flood in 1996. The Mersey is at bankfull stage. The line of debris across the track in the foreground represents the highwater mark of that flood.

The global example of this type of floodplain drainage is the Yazoo River, that runs roughly parallel to the lower Mississippi River for about 300 km through the floodplain, above the confluence with the main river at Vicksburg in the southern USA. The name comes from that of a former American First Nations people, the Yazoo clan. > Continue across the Brook and upslope to the road. Turn round and look back towards the Mersey. Imagine what it might look like during a major flood (Figure 21).
